## HUDSON BORGWARNER DG-200 Transmission Dipstick comparison

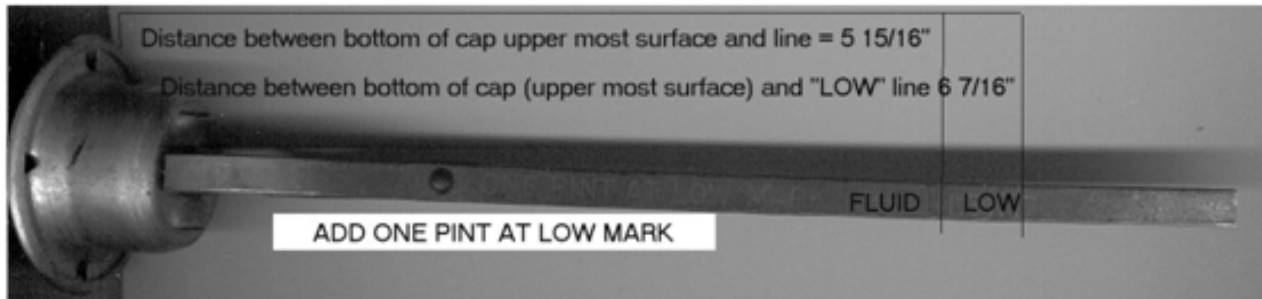
Figure 1

Hudson determined the marking on the dipstick was wrong for their application and issued a field bulletin to dealers and service centers. That information is captured in the picture shown at figure 1.

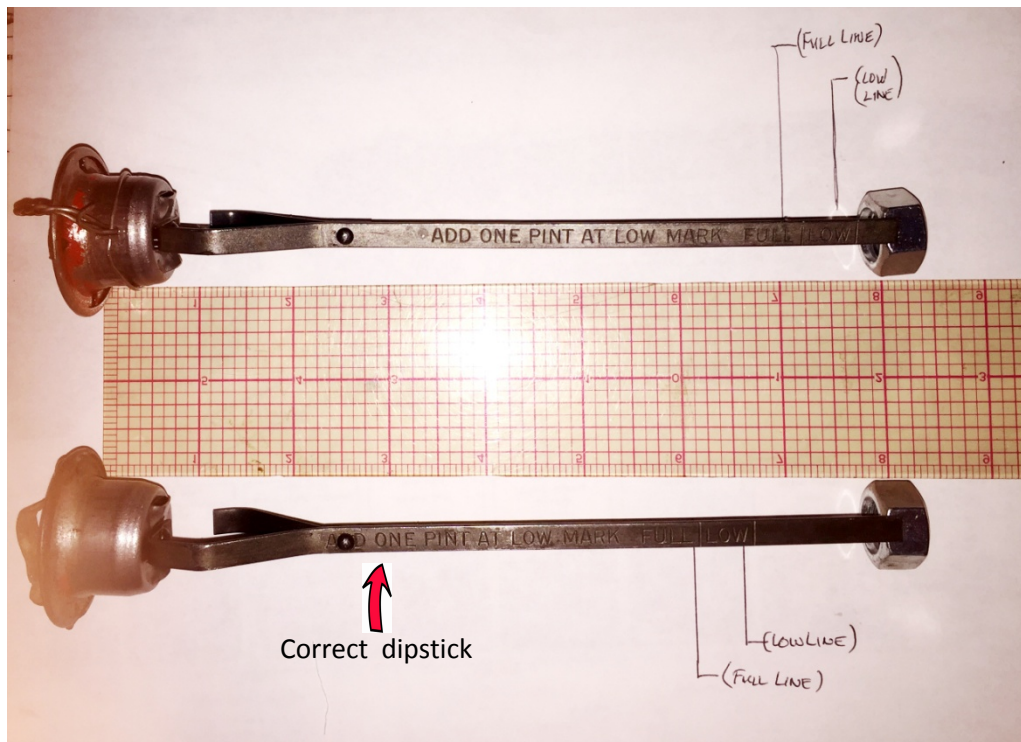
Figure2

The difference between the correct and incorrect making is shown in figure 2.

The dipsticks shown in figure 2 represent the difference in the fluid levels that the transmissions would have to meet the markings. When the incorrectly marked dipstick was removed from a 1954 Hudson Super Wasp equipped with the DG-200; it was replaced with the properly marked dipstick shown in the picture. The transmission fluid service at the time of the dipstick swap was correct for the original dipstick. Bringing the fluid service to the proper levels indicted by the properly marked dipstick required 1.25 quarts of additional fluid.
