Studebaker

Service Letter

SUBJECT ELECTRIC TYPE DOOR WINDOWS AND TAIL GATES
AVANTI AND STATION WAGON MODELS

NUMBER J-1963-10

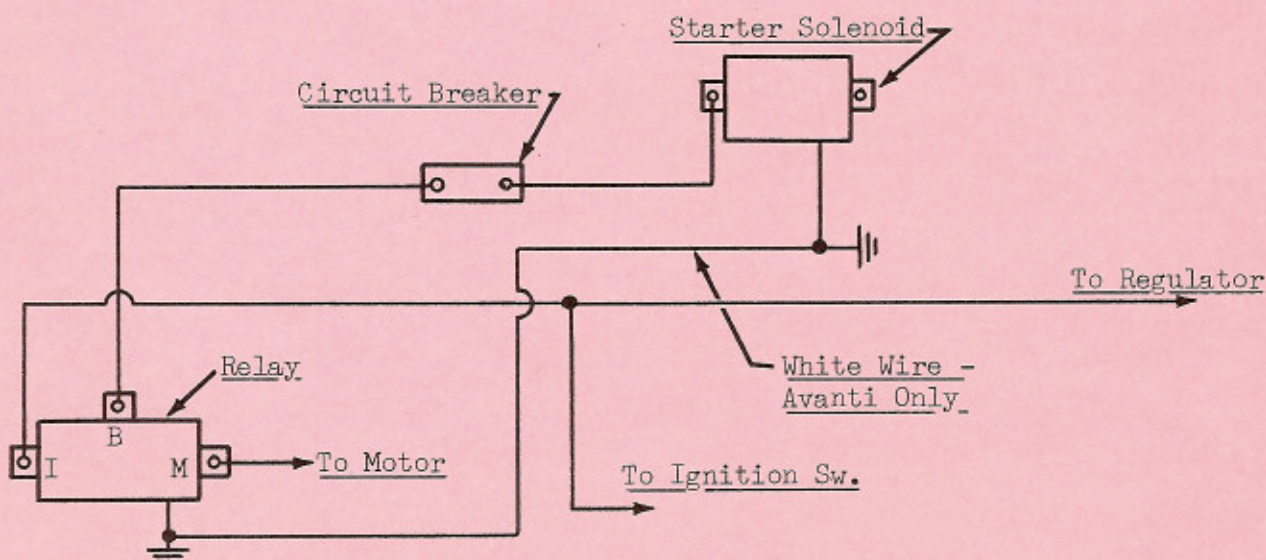
The electric windows on the Avanti models and the electric tailgate window on station wagon models operate with the ignition key turned to the 'ignition position' only and will not operate with the key turned to the left or to the accessories side of the switch. If the electric windows are being serviced, the ignition switch is often left in the 'ON' position for an extended length of time. Prolonged operation of the electric windows can expose the distributor contact points to an abnormal load condition and result in severely burned points.

1. Connect a jumper wire between the rear terminal (M) and the center terminal (B) of the window lift relay located on the left front fender apron.
2. Leave the ignition switch in the 'OFF' position and operate the window lift motors as required while servicing the windows.
3. Remove the jumper wire from the window lift relay after the servicing work is completed.

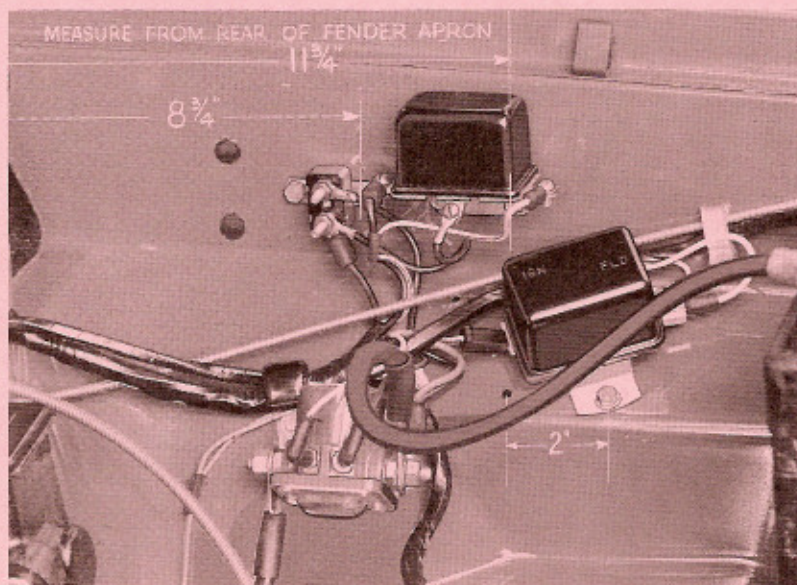
Fig. 1

Effective with serial numbers 63S-26025 and 63V-24019 the voltage regulator, tail gate window lift relay and circuit breaker on 1963 Wagonaire models equipped with an electrically operated tail gate window have been relocated further forward on the left front fender apron to eliminate possible interference between the wiring and the hood torsion bar linkage.

You should inspect all 1963 Wagonaire models with electrically operated tail gate windows for interference at this point when the vehicle is in your service department. If interference exists, the voltage regulator, lift relay and circuit breaker should be repositioned as indicated in Figure 1. After relocation of these units, the unused holes in the fender apron should be plugged.

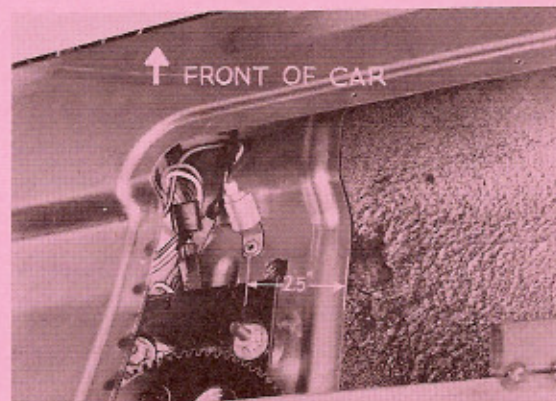
Fig. 1

Effective with production of approximate Serial 63S-29405 and 63V-27396 all 1963 Wagonaire models equipped with an electrically operated tail gate window are equipped with a safety switch which permits the tail gate window to operate only when the tail gate is in the closed position. This safety switch prevents accidental operation of the window when the tail gate is open. This safety feature may also be installed on previously produced 1963 Wagonaire models with an electrically operated tail gate window. The parts required to make the installation are detailed below. These parts are available, upon order, from your Parts Depot.

1. Open the tail gate door and remove the right tail gate door access cover. (Note the location of the round head screw and, upon re-assembly, replace it in its original location).
2. Disconnect the regulator motor ground terminal (Black wire) from the tail gate door. Replace the screw and cable retainer clip.
3. Cut off the eyelet type terminal of the ground wire and install the new blade type Terminal, No. 1546932. Solder the wire to the terminal.
4. Position the safety switch assembly as shown on Figure 1. Drill a hole $2\frac{1}{2}$ " in from the

edge of the regulator mounting plate at a point where the safety switch will fit into the offset of the plate. Use an abrasive paper and clean the area around the hole to provide a positive ground for the safety switch.

5. Install the safety switch and secure it with the Retainer Screw, No. G-9411535. Connect the regulator motor ground wire blade terminal to the terminal of the safety switch.
6. Dress the wires under the retainer clip to prevent any interference between the wiring and the window lift channel through the range of operation of the window.
7. Test operation and reinstall the tail gate door access covers.

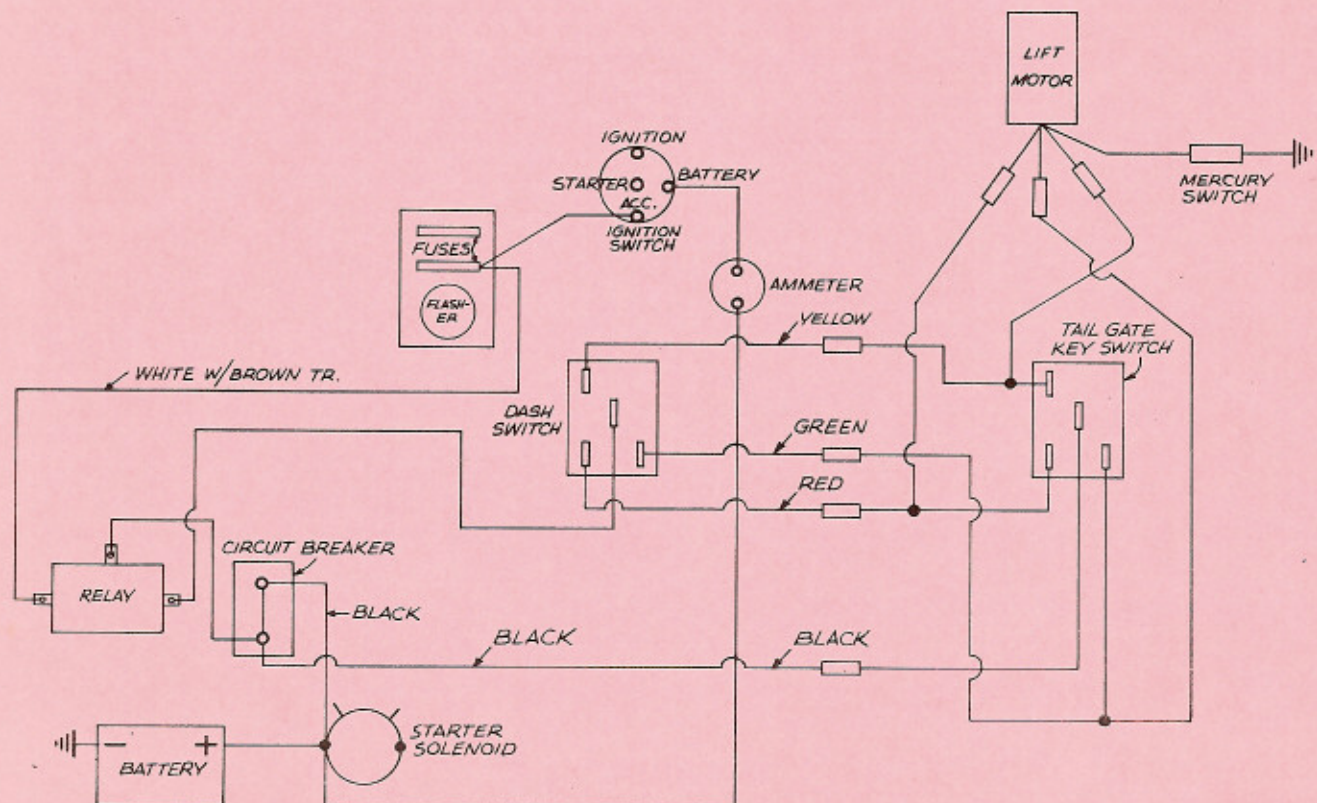
When you encounter a condition of the battery "running down" on 1964 Station Wagon models equipped with an electrically operated tailgate window, the condition is probably caused by improper wiring of the tailgate relay to the fuse block and directional signal flasher assembly.

A complete wiring diagram for the electric tailgate window lift is shown below.

Check the connection of the white wire with brown tracer that leads from the fuse block to the fender mounted tailgate relay and ascertain that it is connected to the terminal on the fuse block and flasher assembly which is closest to the flasher and toward the centerline of the car. A white wire with black tracer, which leads to the accessory side of the ignition switch, is also connected to this terminal.
