Avanti Fiberglass Repair: Nothing to Fear

Bill Henderson

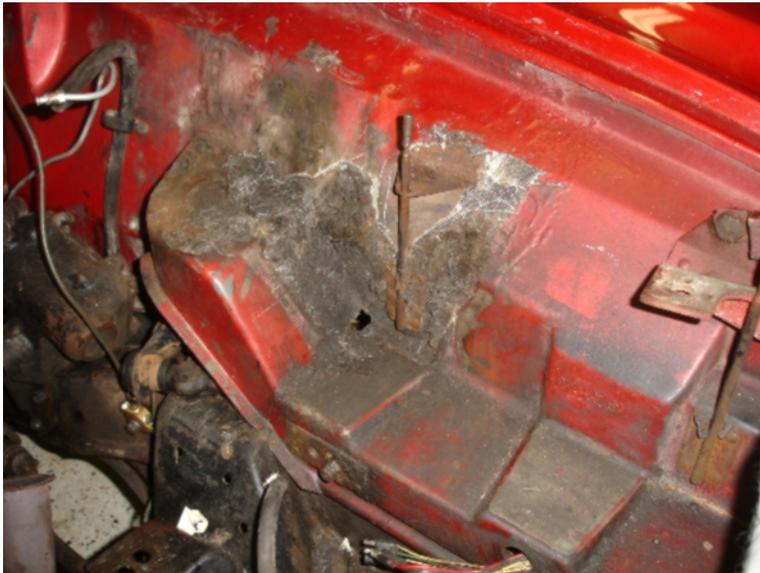
Now, before I bought my car, I already knew that the inner fender panel had been damaged in a prior-owner accident of some kind. But now with the engine out and the wiring removed I could finally see how sloppy the patchwork fiberglass repair was. Quick detective work indicated that at some point my Avanti had been involved in a traffic accident. The impact probably occurred directly from the side, at the center of the front left wheel, and breaking the outside of the fender badly enough that its outside skin was surgically and professionally replaced by a body shop.

But the inner fender did not fare so well. The energy of the collision had sent the heavy battery into motion, tearing it away from its moorings on the inner fender and ripping apart the inner fender from the midpoint to the center of the battery tray before things stopped flying. The under-hood repair was sloppy, distorted and obliterated any trace of the body contours. The area had been covered with fiberglass cloth to finish it, and the woven texture of the fabric was visible through the paint. The repair even bulged up in the middle, but probably the prior owner likely didn't complain and may not have even noticed. Perhaps understandably the owner did not want to pay a lot to fix this area that could only be seen with the hood raised, an area that even then was hidden behind the battery, the brake

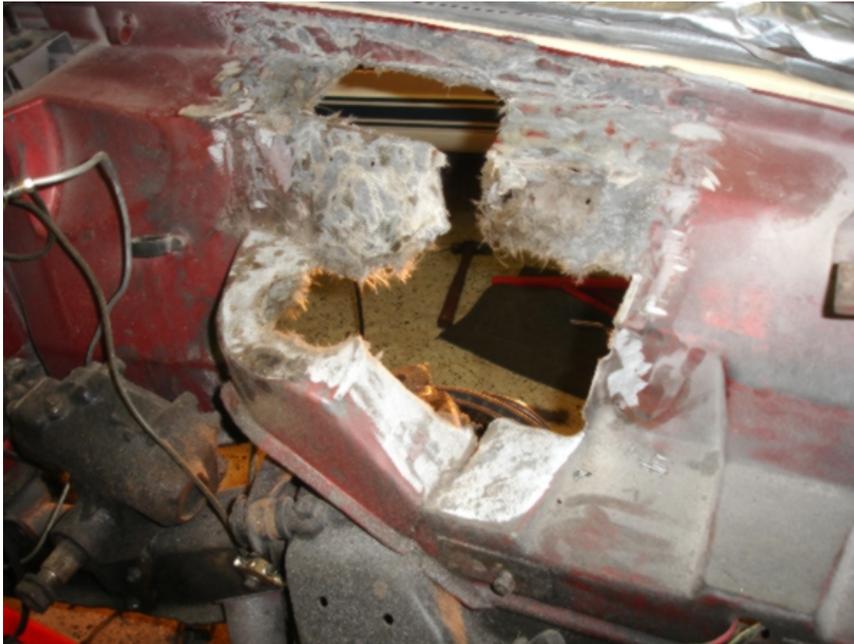
I started poking and pulling at the old repair to see how bad it was. Ouch. You can see in the picture here what my probing revealed... and it was not pretty. Here you can see most of the old repair cut out. I didn't cut it all out from the start, so I would still have something to which I could bond the makeshift forms I made that would shape the new repair. After this photo was taken, I cut more of this area away to remove more of the damage.

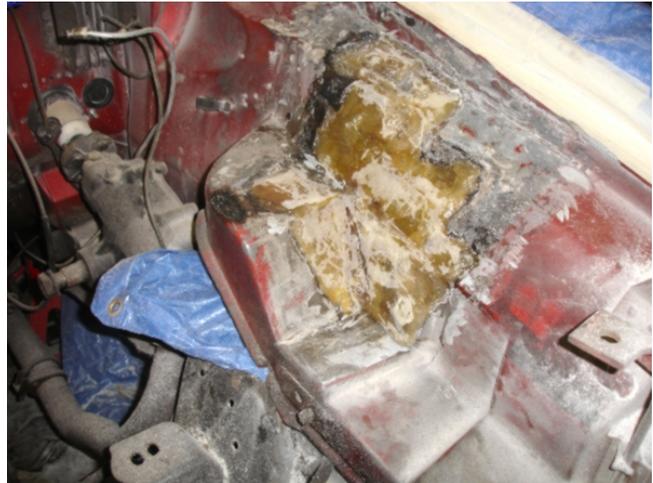
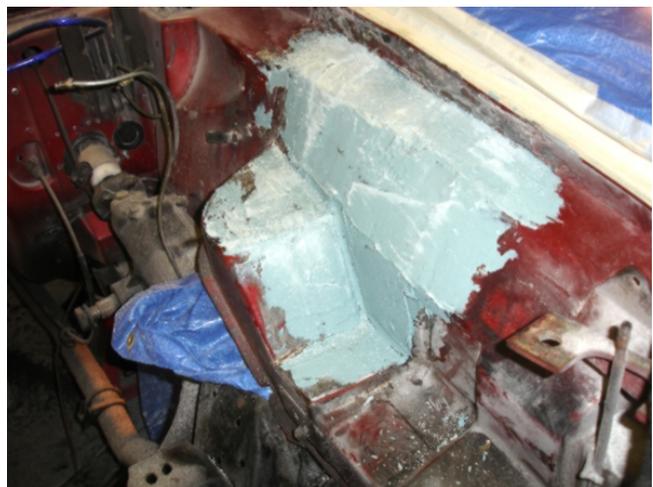
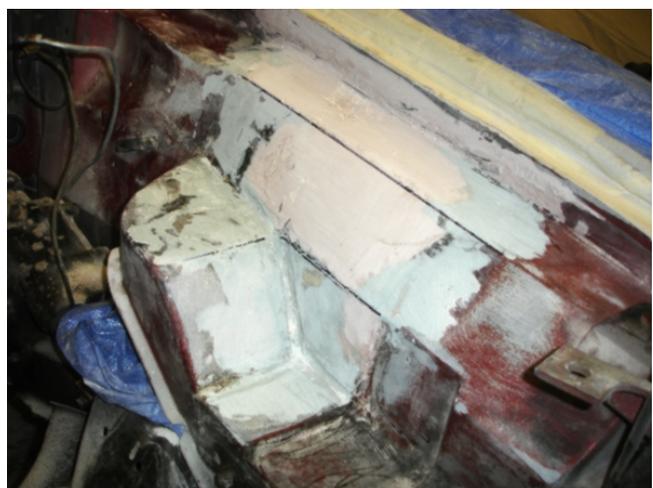
(Top photo) Here is how the repair looked after two surfaces had been completed with a single layer each and the cardboard forms removed. Pretty rough, and from the back it looked like hell, but I was pleased at how smooth the exposed surface was when the release plastic was pulled away. I now had real hope that this was going to work!

One by one I created the original surfaces and creases, layering them from the back just like the first. Once the basic shape was in place work became much easier. Finished this part of the job by going back and covering the entire surface from the back with three layers of mat and resin. In between layers I used my little grinder to knock down any obviously high or misshapen lumps on the back of the repair, inside the wheel well. Each layer of cloth bonded to the old beautifully, and when dry it looked like one thick surface that sounded very solid when one knocked on it with a fist.

Using a high quality two-part plastic body filler (often called by its old name "Bondo") I

smoothed a thin layer over both the front and the back of the repair. It truly did not require much. The Bondo is not structural; here, it is only being used to fill the low spots.
