Studebaker SERVICE BULLETIN

NO. 236

1950

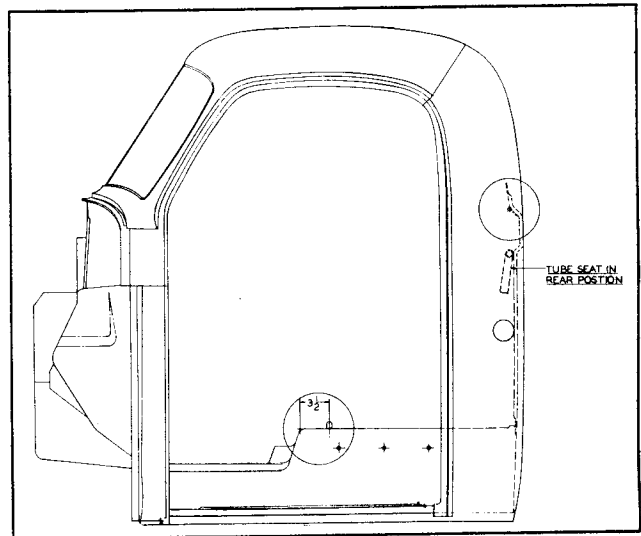
FIG. 1

The new type adjustable seat, Part No. 653050 (LHC) or 653051 (RHC), can be installed in 2R Series cabs produced prior to the above serials (see Fig.1), by drilling ten holes in the floor pan, and bolting the new assembly in place. Location of the bolt holes is shown in Fig.2.

INSTRUCTION FOR INSTALLING ADJUSTABLE TUBE SEAT ON CAB ASSY 652873-REMOVE OR FLATTEN LEFT SIDE SEAT DOWEL 648643 AND PLACE TUBE SEAT ASSY (WITH SEAT TRACKS ADJUSTED TO REAR POSITION) IN CAB IN FURTHEST BACK POSITION & DRILL 10-11/32 HOLES IN FLOOR PAN THRU SEAT TRACK SUPPORT HOLES BOLT IN PLACE WITH ATTACHING PARTS AS SHOWN IN BILL OF MATERIAL.

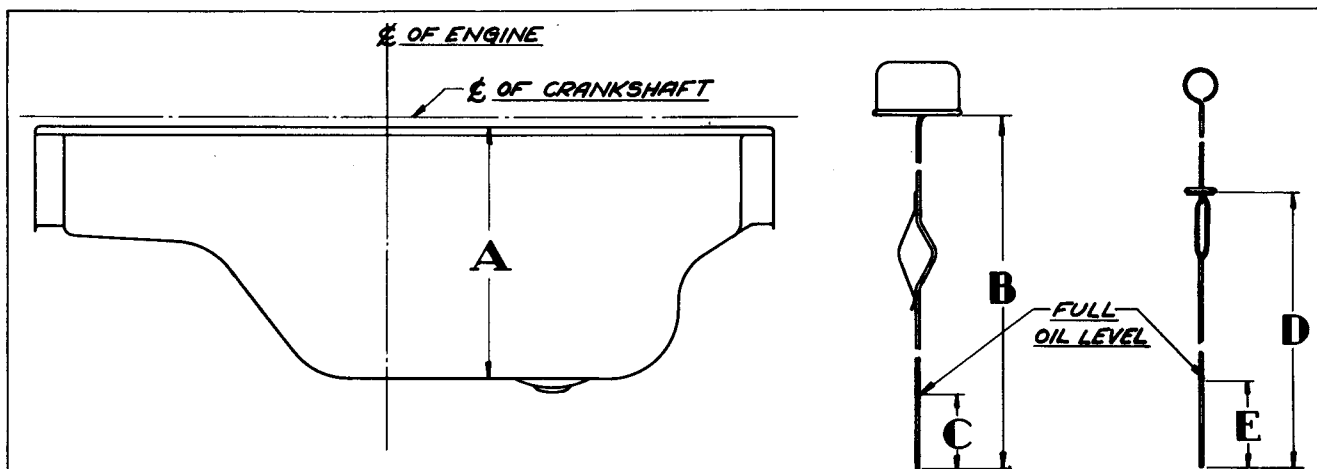
From time to time as truck models change, dimensions of the engine oil pan and also of the oil level gage are changed. This makes it possible in service replacement of the pan or the gage to have the wrong gage for the pan on the truck. As a result, inaccurate oil level readings may be taken.

The accompanying illustration and chart show how measurements of the gage and pan indicate whether the correct gage is being used. Likewise, the chart should be consulted whenever there is any doubt as to which pan or gage is desired in any individual installation.

When taking measurements to check oil pan depth ("A" in the illustration) hold a straight edge flat against the bottom of the pan and extending out beyond one side of the pan. Hold a scale (graduated to 64ths of an inch) against the side of the pan with the end of the scale snug against the underside of the mounting flange. With the scale perpendicular to the straight edge, read the dimension between the straight edge and the underside of the mounting flange. Locate this figure under Column A in the chart. On the same line will be found the correct part number of the pan as well as the part number of the oil level gage which should be used in conjunction with that pan. Conversely, taking measurements B-C or D-E, depending upon the type of gage used, will tell you the part number and depth of the correct oil pan for that gage.

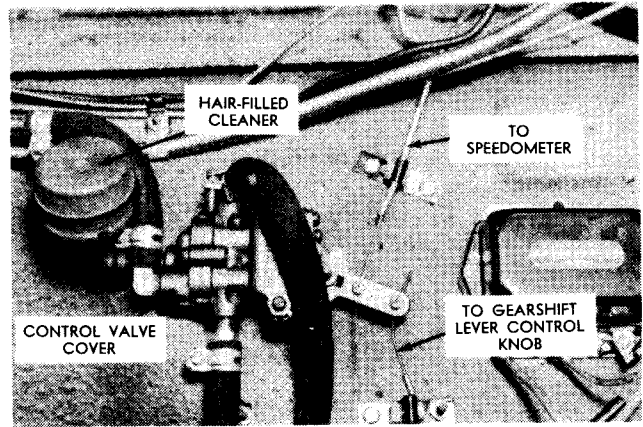
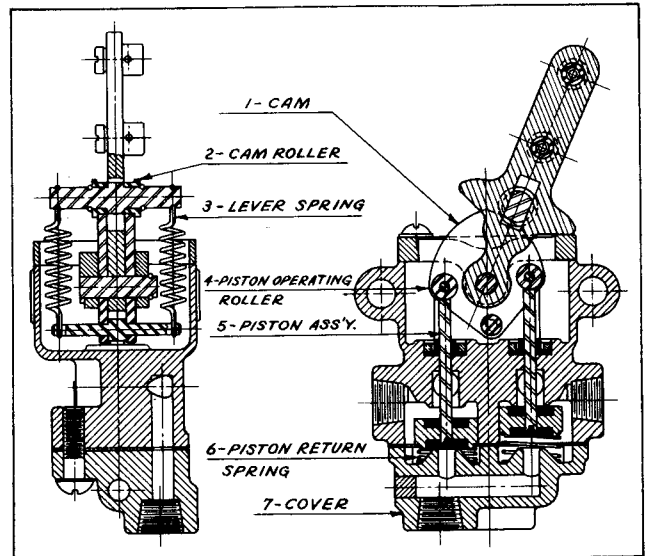
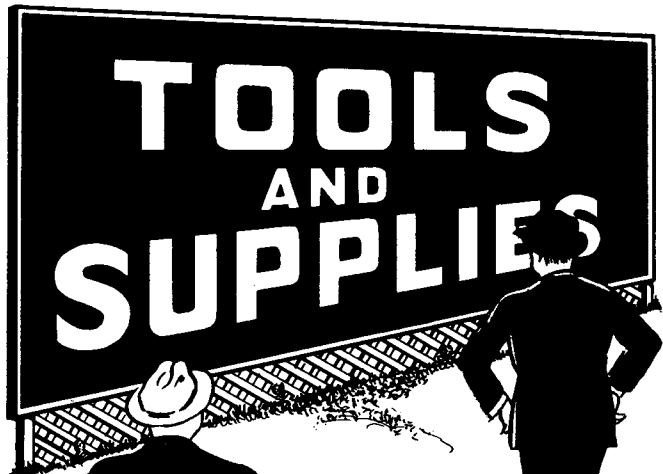
Double-faced poppet type valves are used in the construction of the control valve along with a cam (1) which is spring loaded. Movement of the control valve lever causes the cam roller to travel along the cam. The spring tension on the lever springs (3) maintains a pressure on the valves closing one side of the valve to the vacuum port and opening the other side to atmospheric pressure.

Improper functioning of the valve in some cases will be due to dirt or other foreign material entering the valve or, in extremely cold weather, it may be due to failure of the cam to function properly due to the lubricant becoming sticky. If the cam does not operate properly in cold weather the valve will not shift the rear axle from one ratio to the other. Poor operation of the cam can usually be corrected by lubricating the cam mechanism with penetrating oil.

If dirt has entered the valve and lodged on the valve seats, causing leaks, it will be necessary to remove the cover (7) and clean the valves and seats. If the valves are damaged it will be necessary to replace them, using repair kit, Part No. 679902. The kit consists of the following parts:

The hair-filled sealed cleaner should be serviced as operating conditions require. Under severe dust conditions it may be necessary to service the unit frequently. Remove the cleaner and wash in cleaning solvent. Allow time for the solvent to drain, then dip cleaner in light engine oil; allow excess oil to drain before replacing. Excess oil left in cleaner may affect valve operation.
