Studebaker

SERVICE BULLETIN

N O . 2 5 3

1 9 5 1

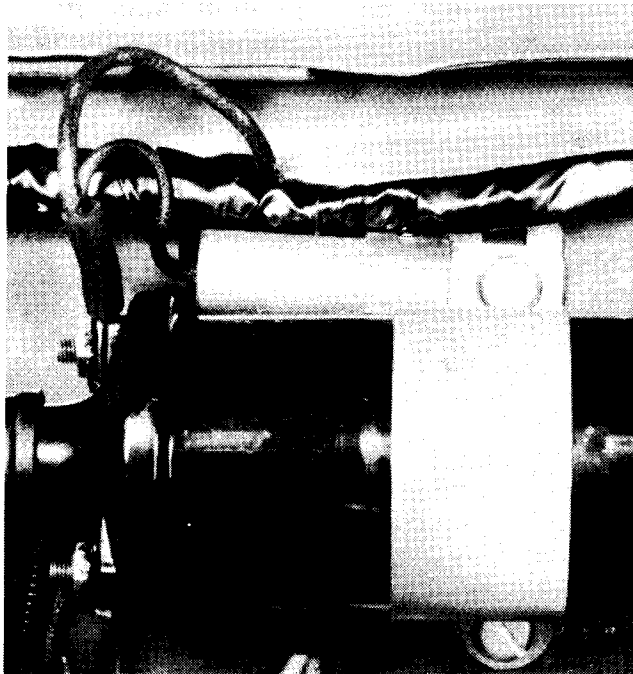
RADIO IGNITION NOISE CAUSED BY INCORRECT CONDENSER MOUNTING

It is important that the radio condenser be mounted under the top mounting screw of the coil and that the pigtail be connected to the ignition switch side of the coil on 1951 Commander (H) models.

If this condenser is connected to the distributor side of the coil it will result in ignition interference in the radio reception and will also cause greatly reduced distributor breaker point life.

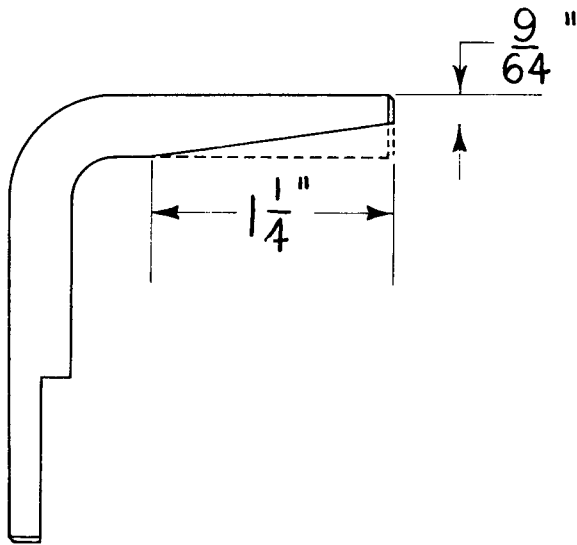
SHIFT ROD ADJUSTING TOOL J-4690 MODIFIED

As a result of a small change in the shift rod box of 1951 passenger car models equipped with standard or overdrive transmissions, the shift rod adjusting tool, J-4690, may not perform as expected.

To use this tool, it may be necessary to modify it by scribing a vertical line across the round end of the tool $9/64$ " from the outer surface, as the tool appears when lying flat (see illustration). Make another mark on the inner surface of the tool $1-1/4$ " from the round end of the tool.

Next grind or mill the material away from the inner surface of the tool until a flat incline is produced connecting the mark on the end with the mark $1-1/4$ " inward from the end. This will result in a wedge-shaped end that can be inserted into the shift box to lock the shift rod levers on those standard or overdrive equipped 1951 models for which the step-shaped end of the tool cannot be used.

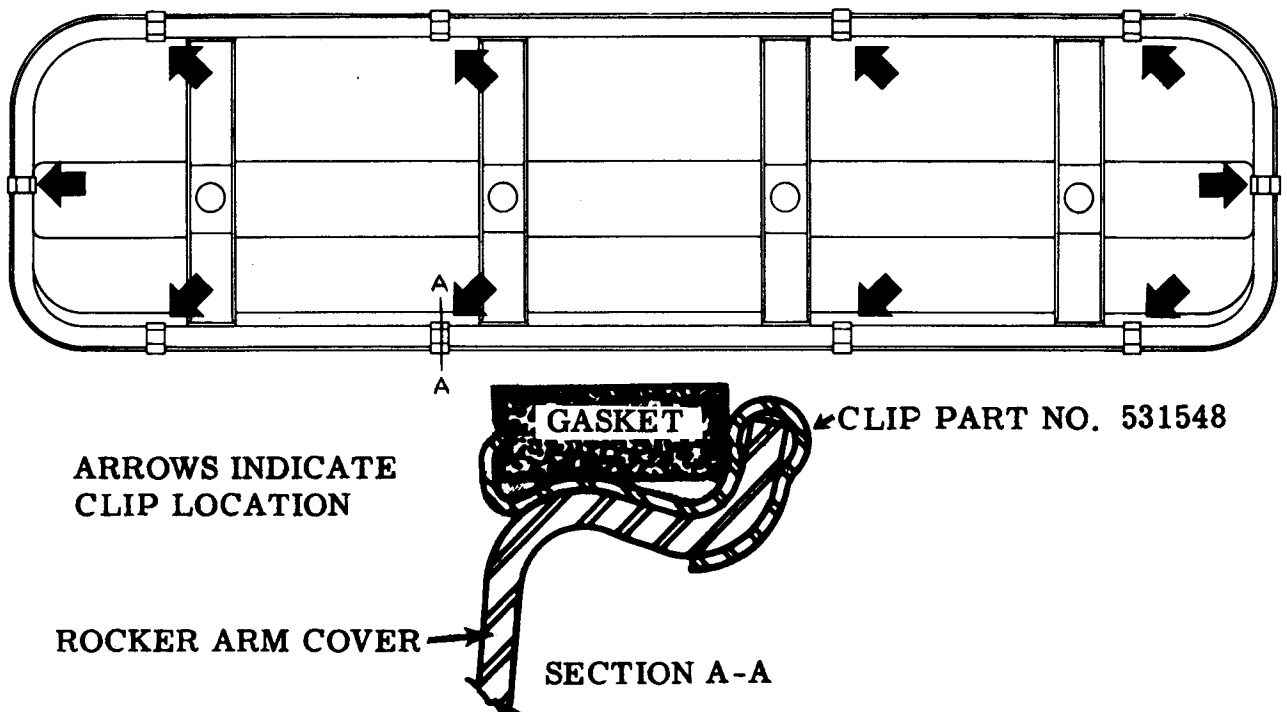
The gasket retaining bands now used in production in the rocker arm covers, are not adaptable for use in the rocker arm covers on V-8 engines prior to V-60197. Therefore, when it is necessary to replace the rocker arm cover gasket on cars produced before Engine No. V-60197, it is recommended that the original cover be fitted with ten gasket retaining clips, Part No. 531548, as shown in the illustration at the bottom of page 4.

AT LEFT -- PLAN VIEW OF ROCKER ARM COVER AS SEEN FROM THE UNDERSIDE, SHOWING CLIP LOCATIONS. THE CROSS SECTION SHOWS HOW CLIPS RETAIN THE GASKET IN PLACE.

1. Remove the rocker arm cover and scrape out the old gasket.
2. Assemble ten of the Part No. 531548 clips in the approximate positions shown in the drawing at left.
3. Insert the gasket (Part No. 531414) in the clips making sure that the tab on the gasket is toward the inside or high side of the cover. (This will ensure that the radii of the gasket match the radii of the cover.)

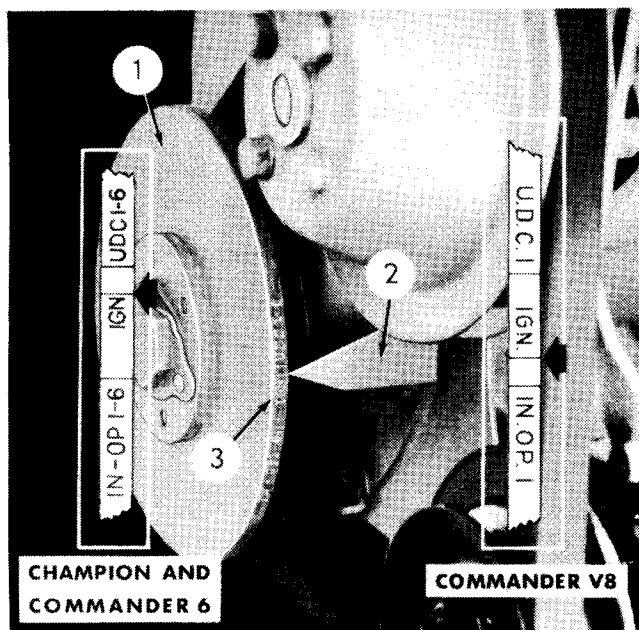
The boxed inserts in the accompanying illustration are designed to show the difference in location of the IGN marks used for timing on the Commander-6 (17A and earlier) and Champion (10G) engine, and the Commander (H) V8 engine.

1-VIBRATION DAMPER 2-POINTER 3-IGN MARK

To avoid the possibility of using the wrong mark for timing, mechanics should be advised of two things: (1) the correct timing IGN mark is the straight line immediately following the letters IGN (to the right of the letters as they are read) on the edge of the vibration damper flywheel; (2) this mark should be painted yellow or white. If paint has accidentally entered any other mark, it should be removed. If the IGN mark does not stand out clearly under the neon timing light, it might be advisable to polish the area clean with sand paper and then chalk the letters IGN, as well as the mark immediately following them, to make them more prominent.

In the illustration the heavy black arrow points out the IGN mark as it is seen on each vibration damper flywheel.
