Studebaker

SERVICE BULLETIN

NO. 257

1951

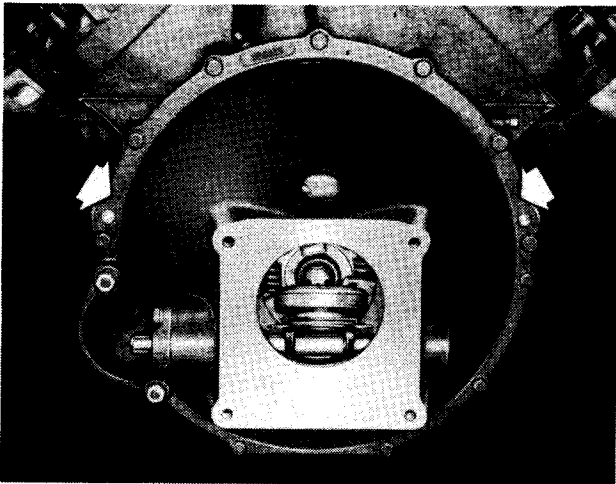
CLUTCH OR TORQUE CONVERTER HOUSING DOWEL HOLES - COMMANDER H MODELS AND CHAMPION MODELS WITH AUTOMATIC DRIVE

When drilling new dowel holes in torque converter housings on Commander H models and Champion models equipped with Studebaker Automatic Drive, use an 11/32" drill, (see illustration below for location), then ream the holes to .376" - .377" (9.55 - 9.58 mm.) and install service dowel pins.

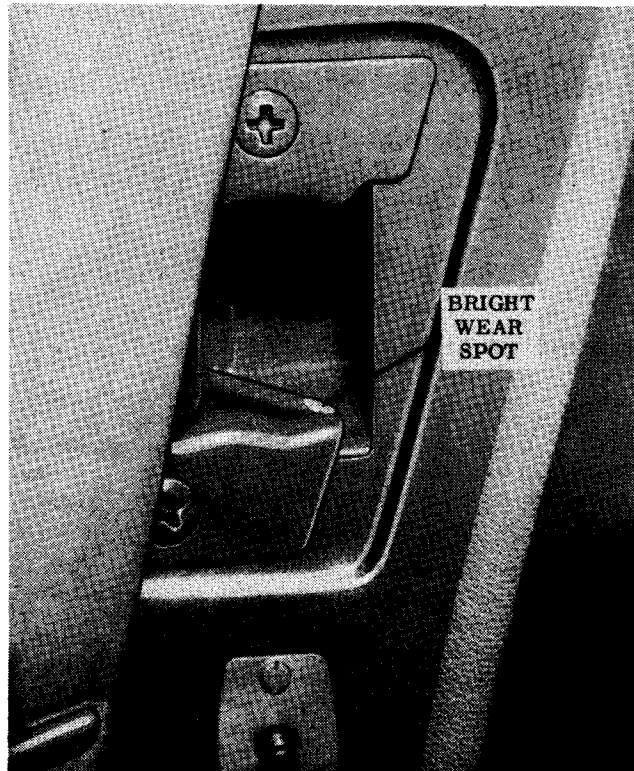
An unusual noise may occur at the front door of some 1951 models. The noise resembles a creak or groan and is sometimes more apparent under a brake application. This noise is

traceable to slight misalignment of the hinge mounting holes. It can be identified by a bright wear spot on the mounting bracket (see illustration above).

This condition can be corrected by filing off either the hinge bar or the bracket at the point of interference.

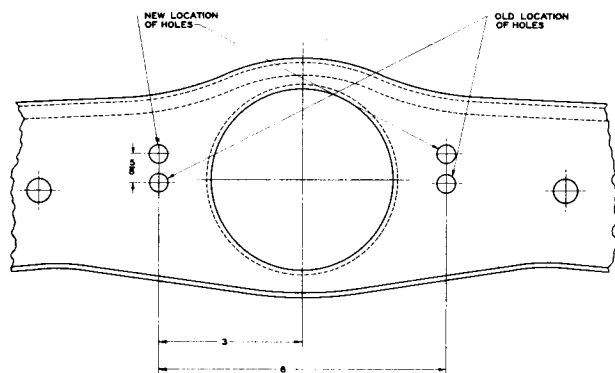
In production of frames, Part Nos. 529160, 529161, 529162, 529163, 529164, and 529165, used on 1951 passenger car models, the 13/32" diameter mounting holes for the propeller shaft support bearing have been located 1/2" higher on the crossmember than before. This change provides a more ideal angularity of the propeller shaft members under severe operating conditions and should reduce the vibration sometimes experienced in rapid acceleration or open-throttle hill-climbing.

In service, where this condition of excessive vibration is encountered and all other factors

have been found normal, it may be possible to minimize it by relocating the support bearing 1/2" to 5/8" above their present position. (See drawing.) If this correction is made, it is of extreme importance that the holes be exactly above the original holes in the cross-

member. Any deviation sideways, inequality of the height of either hole, or improper spread between the holes can result in misalignment of the propeller shaft support insulators and introduce other drive line disturbances. A check should be made for possible interference at the universal joint spline lubricant fitting. If an angular fitting results in interference it can be replaced with a straight fitting.

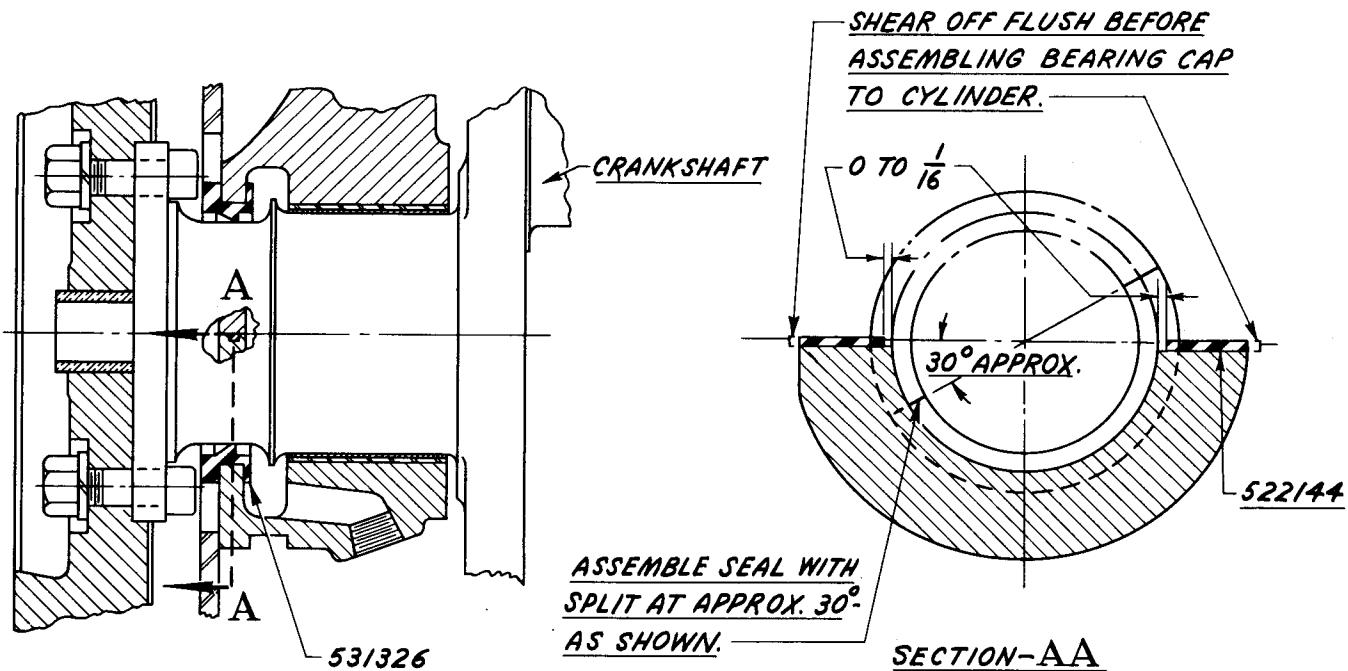
ABOVE: CHAMPION-TYPE INSTALLATION

A new design of Brummer rear main bearing oil seal is now available for service installation. The new seal is in two pieces, similar to that used in the 1951 Commander V-8 engine. The two-piece seal simplifies installation and should result in a better and longer lasting seal.

In the installation of the new type seal, the Neoprene "spaghetti" seals are now cut flush with the outside of the bearing cap and from 0 to 1/16" in from the inner surface of the cap. See drawings on page 6.

Installation of the two-piece Brummer seal is made as described on page 34 of the Engine section of the 1951 Passenger Car Shop Manual. Wood filler blocks are installed as in the past on Champion- and Commander-type six cylinder engines. The new parts are listed at the bottom of the page.
