Studebaker

SERVICE BULLETIN

NO. 266

1952 STARLINER MODELS BODY SERVICING ADJUSTMENT PROCEDURES

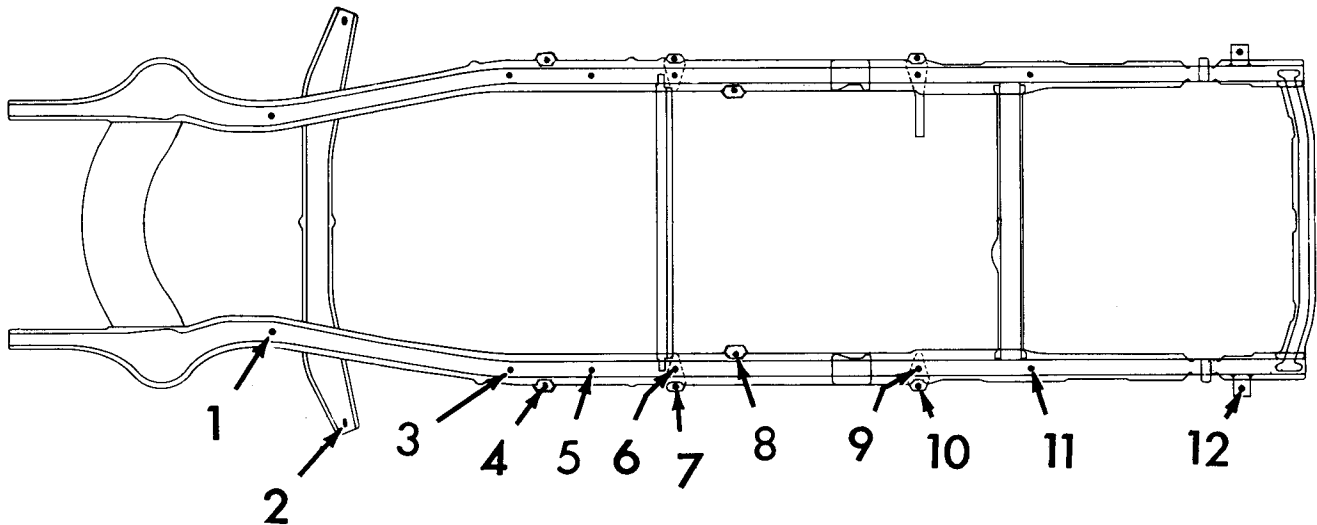
If the door opening is too large or too small across the belt line, the body can be shimmed on the frame to move the top of the rear quarter section forward or rearward. Two types of body shims are used, a steel plate and a rubber fabric pad. Each type is available in thicknesses of $1/8$ " and $1/4$ ". The steel plate must be used when shimming to change the body position. The rubber fabric pad has very little effect in changing body position and is

used primarily as an insulator. A rubber pad should be used at each hold-down bolt position. Body bolt locations are shown in Figure 1. Because of the positions of the reinforcing members in the body, the door opening is only effected by shimming at body bolts 2, 4, 7, 8, 10, and 12.

First, align the door with the cowl panel as outlined under Door Alignment and Adjustment. Then, with exception of body bolt (1, Fig. 1), loosen all body bolts on the side on which the correction is to be made. With the body bolts loose, the body free on the frame, check the position of the rear quarter section to determine whether the condition was caused by distortion of the body because of improper original shimming. If the condition no longer exists, insert body shims as required at the various bolt positions to maintain the same body position in relation to the frame.

If the door opening is too small at the top (door striking the rear quarter section), add a shim at body bolts 2, 4, 7, and 8 and remove the shims from bolts 9, 10, 11, and 12. If the shim packs at body bolts 2, 4, 7, and 8 are unequal, add shims as necessary to obtain the same size shim pack at each bolt. If shims are not present at bolts 9, 10, 11, and 12, then it will be necessary to add another shim at bolts 2, 4, 7, and 8. The body must be high enough in the center section to permit the top of the rear quarter section to move rearward when bolts 10 and 12 are tightened. Tighten the bolts 2, 4, 7, 8, 10, and 12 securely and check the opening. Add shims as necessary until the desired opening is obtained. After the desired opening is obtained, insert shims at the other bolts to fill the existing gap resulting from the shimming, and tighten all bolts securely.

remove the shims at bolts 2, 3, 4, 5, 6, 7, and 8 and add a shim at bolts 10 and 12. Then tighten the bolts at the center section and check the opening. Adding shims at the bolts 10 and 12 will cause the top of the rear quarter section to move forward. If the desired opening has not been obtained, loosen the bolts, add another shim at bolts 10 and 12 and again tighten the center section bolts. Repeat the procedure until the desired opening has been obtained. Then insert shims at bolts 9 and 11 to fill the existing gap resulting from the shimming at bolts 10 and 12.

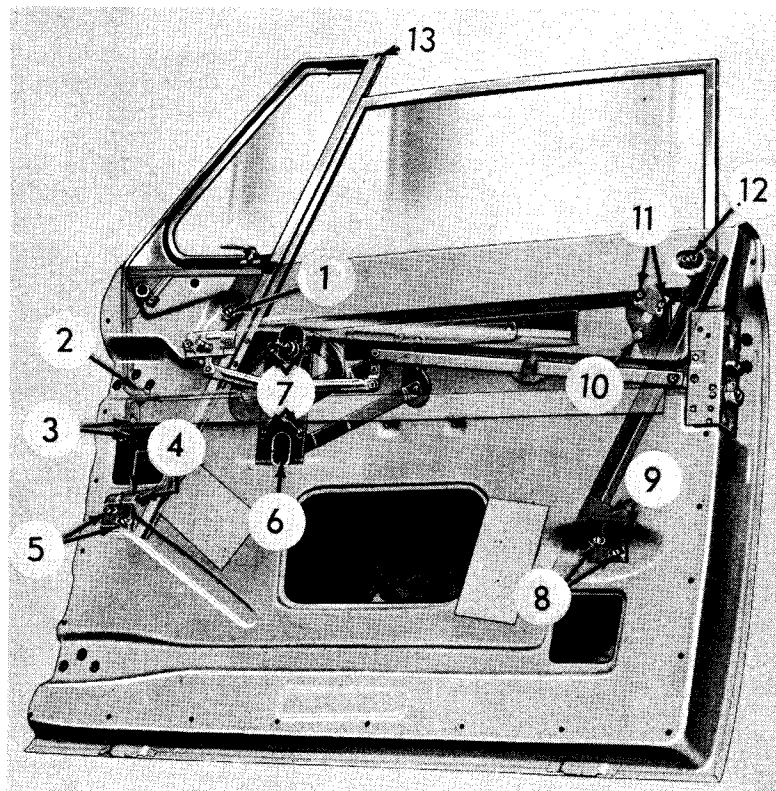
FIG. 2

Adjustments are made by means of elongated holes in the ventilator assembly, in the brackets, and in the door panel. Figure 2 illustrates the points of adjustments. It may be necessary to enlarge the holes or shim out the brackets if additional adjustment is required to properly position the ventilator assembly.

To move the assembly forward or rearward, loosen the ventilator frame-to-door panel screw (1, Fig. 2), the ventilator frame-to-front bracket nut (2), the two ventilator frame rear bracket-to-door panel screws (5). Also, loosen the window assembly rear guide screws (8 and 12) to allow the door window to shift with the ventilator assembly. Then shift the ventilator frame forward or rearward as required, so that the front weatherseal lip comes in easy contact with the ventilator frame the full length of the frame. Do not force the frame against the weatherseal. Tighten the retaining screws and nut.

To correct for forward tilt, top too far forward, loosen the ventilator frame-to-door panel screw (1, Fig. 2), the two rear bracket-to-door panel screws (5), the upper and lower rear guide screws (8 and 12) and remove the ventilator frame-to-front bracket nut (2). Tilt the assembly rearward as required, while at the same time shifting the assembly forward to properly position it against the front weatherseal; then tighten the screws (5, 8, 1, and 12) securely. Loosen the two ventilator frame front bracket-to-door face cap screws (3), and shift the bracket upward, cornering the bracket against the door face and the ventilator frame. Tighten the cap screws (3), install the nut (2) that holds the ventilator frame to the front bracket and tighten securely.

To correct for rearward tilt, loosen screws (1, 3, 5, 8, and 12), frame-to-front bracket nut (2), and shift the assembly upward and rearward as required. Tighten the screws (1, 5, 8, and 12); then corner the front bracket and tighten nut (2) and screws (3).

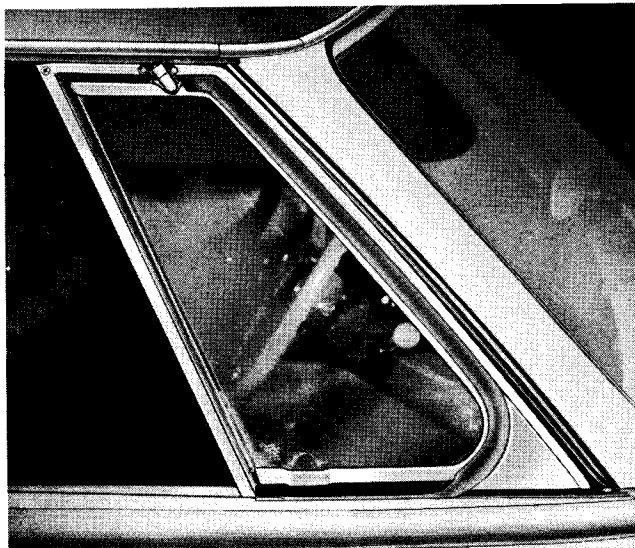
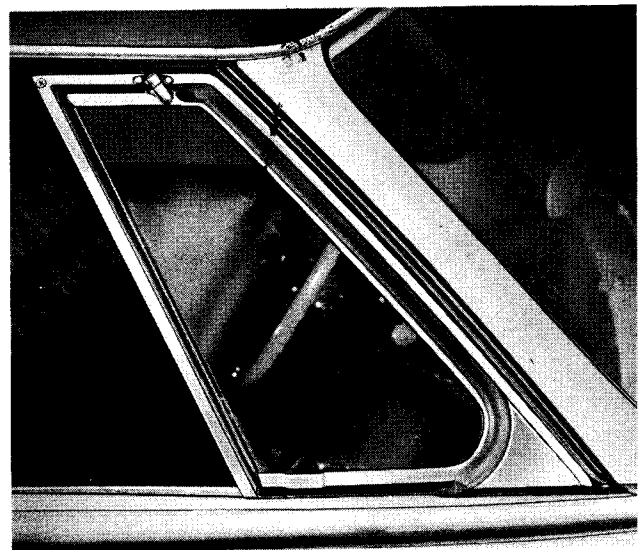
Forward tilt or rearward tilt of the ventilator assembly is as shown in the Figures 4 and 5, respectively. Either the top of the assembly or the bottom of the assembly is too far from the front weatherseal, resulting in a cocked position.

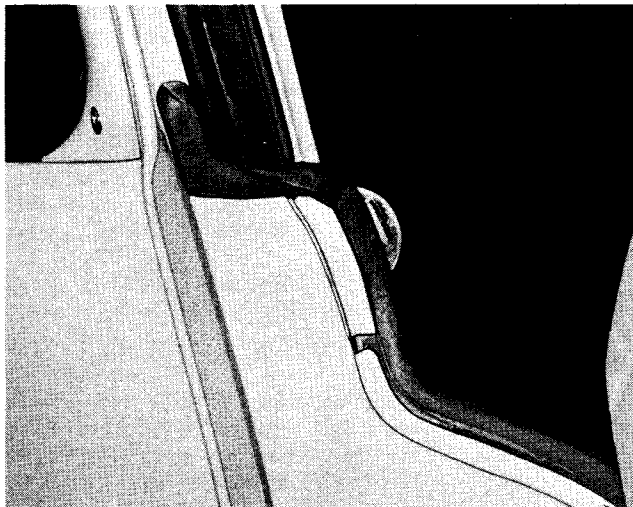
FIG. 16

Installation of the weatherstrip will eliminate leaks which originate at the front of the door at the belt line. The weatherstrip entered production in South Bend effective with Body Nos. 2895 for the Champion and 6355 for the Commander; in Los Angeles with Car Serial Nos. G-910603 and 8818234, respectively.

To install the weatherstrip, first remove the old door front weatherstrip from the channel. Remove the front weatherseal from the retainer. Then cut the front weatherseal retainer gasket so that it is parallel to the weld line as shown in Figure 13. Insert the "dog leg" end of the weatherstrip in position as shown in Figure 14 to check the fit of the weatherstrip against the retainer gasket. Install the front weatherseal in the retainer making sure the upper end is butted against the end of the upper weatherseal. Then cut the weatherseal so that the outer edge is on a horizontal line with the curve at the windshield post as shown in Figure 15 and at the same time the cut should follow the angle at

which the front weatherseal retainer gasket was cut. Apply weatherstrip cement to the door front weatherstrip and the channel and also to the windshield post. Cement the weatherstrip in position. Figure 16 illustrates the completed installation.

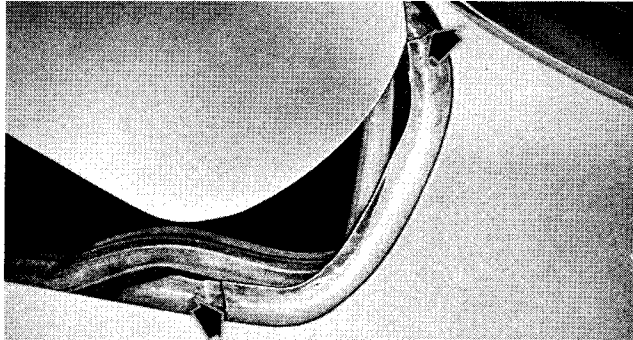
FIG. 19

At the upper corner on each side of the luggage compartment there is an insert in the channel which overlaps the ends of the side and top weatherstrip channel. Misalignment at the time of welding may result in an opening at the

overlap, which will result in a leak beneath the weatherstrip. To correct, pull the weatherstrip out enough to expose both joints (indicated by arrows in Fig. 19), apply sealer to the joints and, recement the weatherstrip in the channel.
