Studebaker

SERVICE BULLETIN

NO. 274

1953

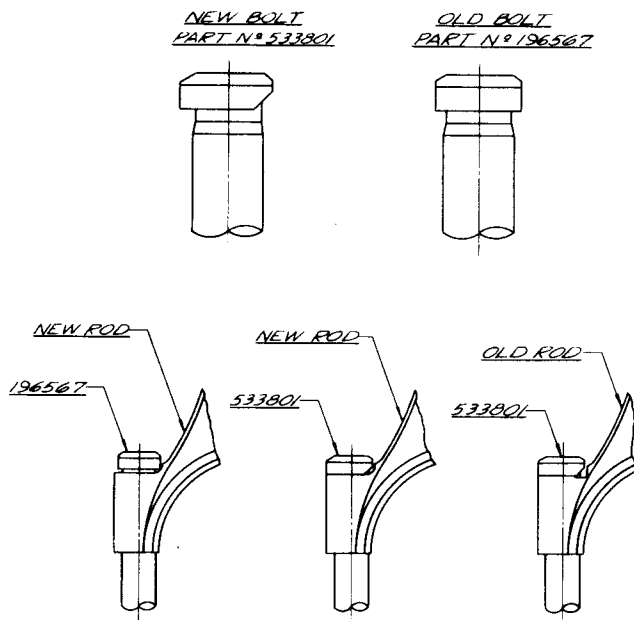
The machining of the inner edge of the connecting rod head seat in the upper half of the rod used in Champion-type engines is now changed to a form similar to that used in the Commander V-8 engines. The undercut along the inner edge of the seat is being abandoned in favor of a generous radius at this point. See the drawings. The use of this radius requires a corresponding change in the connecting rod cap bolt head to prevent interference.

But the new-type rod *must* use the new-type connecting rod cap bolt, Part No. 533801. This bolt can also be used with the original-type connecting rod. On the other hand, do not use the original-type connecting rod cap bolt (Part No. 196567) on the new-type connecting rod. Such use will cause interference between the bolt head and the rod radius, leading to rapid fatigue and possible breakage of the rod.

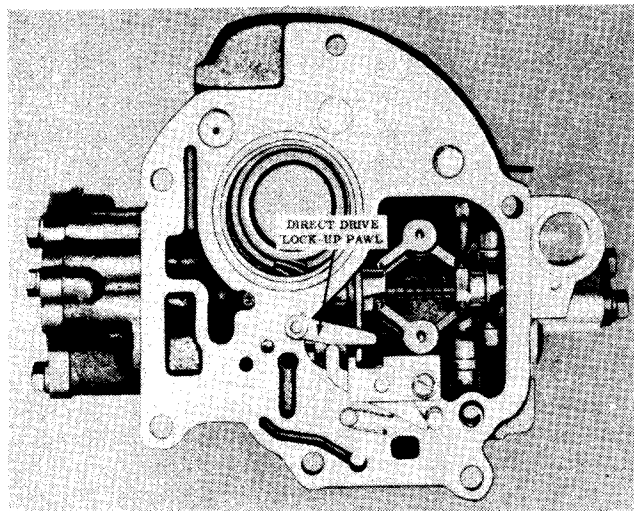
FIG. 1 - EXTENSION CASE ASSEMBLY, PART NO. 529984 FOR 1951, 1952, AND 1953 COMMANDER MODELS WITH STUDEBAKER AUTOMATIC DRIVE.

Only one extension case assembly, Part No. 529984 (see Fig. 1), will be furnished by parts depots for replacement purposes in 1951, 1952, and 1953 Commander models equipped with Studebaker Automatic Drive. The assembly is installed in 1953 Commander models after first removing the direct drive pawl (see Fig. 2).

If the owner *does not want* the part-throttle downshift, install the Part No. 529984 Extension Case Assembly exactly as you received it from your parts depot (see Fig. 1). This assembly has the direct drive lockup pawl in place and, to prevent part-throttle downshift, it should be retained.

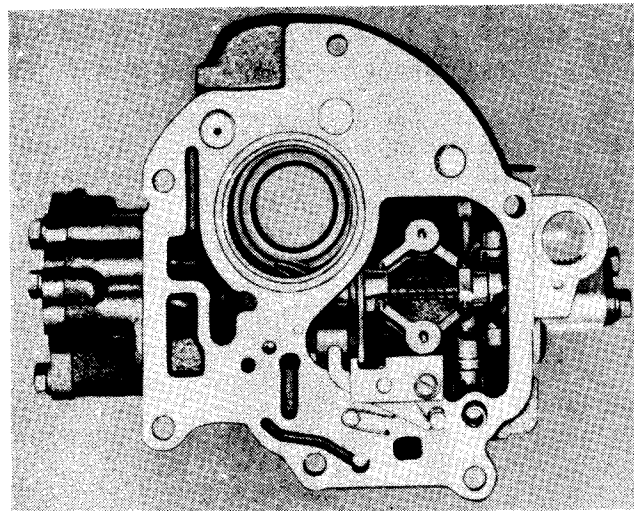
FIG. 2 - SAME CASE WITH DIRECT DRIVE LOCK-UP PAWL REMOVED BEFORE INSTALLING IN 1953 COMMANDER MODELS WITH STUDEBAKER AUTOMATIC DRIVE.

If the owner wants the part-throttle downshift (operation like 1953 Commander and all Champion models with Automatic Drive), it is necessary only to remove the direct drive lockup pawl before you install the Part No. 529984 Extension Case Assembly. Thus modified, it will appear as shown in Fig. 2. The other related direct drive lockup parts need not be removed from the extension case assembly.
