Studebaker

# SERVICE BULLETIN

NO. 278

1953

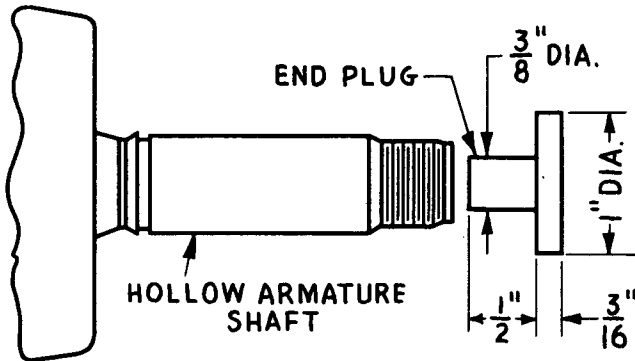
**DAMAGE TO HOLLOW ARMATURE SHAFTS**

Field reports show that some armature damage has resulted from pounding on the drive end of hollow shafts during disassembly or assembly of the pulley or the drive end frame. Pounding can result in the following damage:

1. Armature laminations may become loose on the shaft as the result of the sudden end thrust. This allows the laminations to shift endwise during rotation, damaging the insulation between the lamination and commutator. This will cause armature failure due to shorting between the leads. Also, shifting of the lamination will produce a vibration in the generator which eventually causes the leads to break.
2. The end of the shaft may be expanded enough to prevent assembling the bearing or commutator end frame.

3. The threads on the end of the shaft can be damaged, preventing assembly of the nut which holds the pulley in place.
4. The shaft may be forced through the end of the commutator end frame and the bushing driven out of place.
5. The ball bearing in the drive end may become brinelled or dented causing bearing failure.

Therefore, care must be taken when disassembling or assembling the generator to avoid pounding on the end of the shaft. Always use a gear puller to remove the pulley or the end frame. To prevent damage to the shaft when using a puller, insert a plug in the end of the shaft. A plug as illustrated above, or some other suitable plug, may be used.

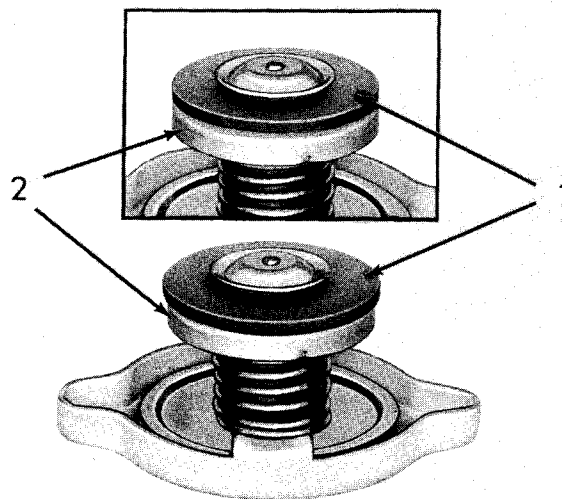
FIG. 2 • 1. RUBBER GASKET 2. BRASS SPRING SEAT

THE RUBBER GASKET (1) OF THE PRESSURE CAP AT THE TOP OF THIS PICTURE IS THE RIGHT SIZE. IT DOES NOT PROTRUDE OVER THE EDGE OF THE BRASS SPRING SEAT (2). IN THE PRESSURE CAP AT THE BOTTOM OF THE PICTURE, THE GASKET (1) IS OVER-SIZE AND EXTENDS BEYOND THE EDGE OF THE SPRING SEAT (2). THIS PRESSURE CAP SHOULD BE DISCARDED.

- b) **Inoperative Radiator Pressure Cap** If the pressure cap does not open when the prescribed 7 lb. pressure builds up in the system, the excess pressure will bulge the upper tank, open the seams, or blow off the radiator hoses. This causes loss of coolant, resulting in overheating.

diator. If the hose is blown off, re-install or replace. Install a new pressure cap and inspect it carefully to be sure that the rubber gasket at the bottom does not extend beyond the edge of the brass seat between the spring and the rubber gasket. See Fig. 2. It is when this gasket is of greater diameter than the brass spring seat that the rubber gasket seals against the walls of the radiator filler neck and prevents the pressure cap from opening at the desired 7 lb. pressure in the cooling system.

essary. Examine the new radiator cap to be sure that the rubber gasket does not extend beyond the edge of the brass spring seat (see Fig. 2). Use only caps in which the rubber gasket is

slightly smaller than the pressure seat.
