Service Bulletin

NO. 325

*Studebaker and
Packard Clipper*

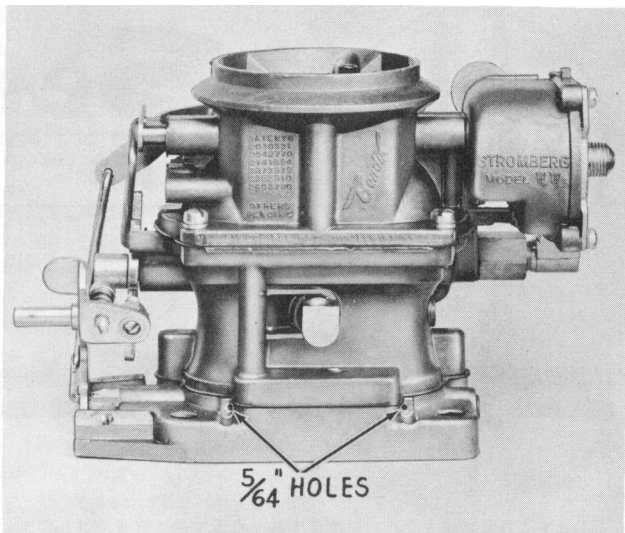
Fig. 2

on a complaint of hard starting or prolonged cranking to start a hot engine on models equipped with a supercharger, modifying the carburetor and air chamber cover as outlined below will provide considerable improvement.

1. Remove the carburetor air chamber cover and remove the carburetor from the engine.
2. Drill a $\frac{7}{64}$ " hole into the vent passage at the location shown in Fig. 1. Then, drill two $\frac{5}{64}$ " holes in the throttle body at the locations shown in Fig. 2. It is not necessary to disassemble the carburetor to drill the holes but care should be taken to prevent chips from entering the carburetor.
3. If the air chamber cover does not have a

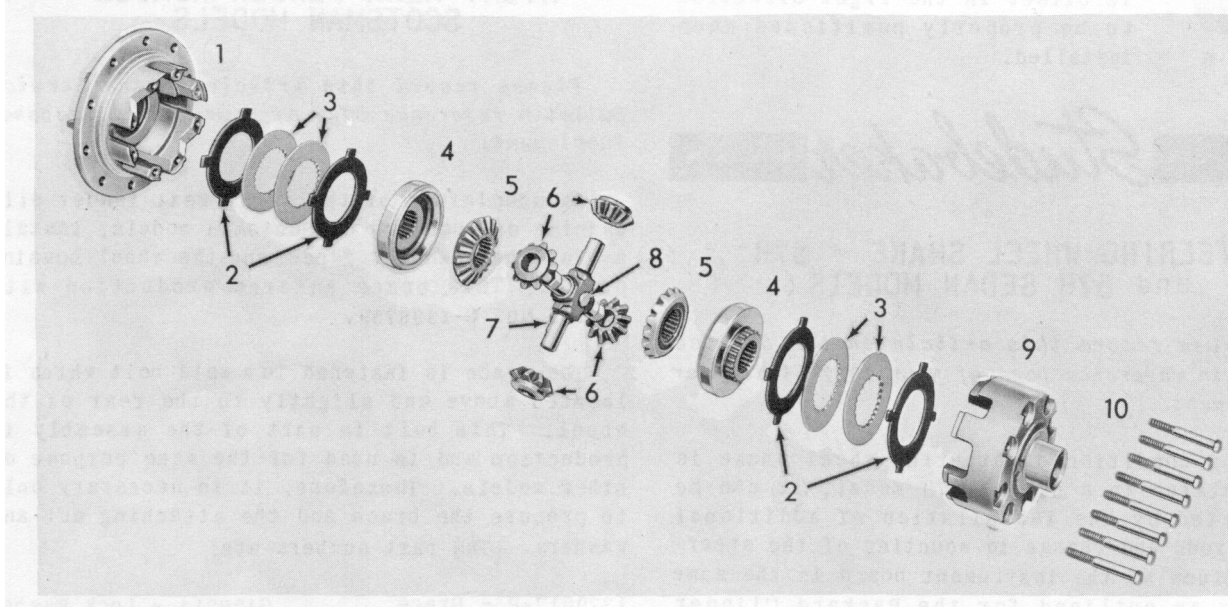
A change has been made in the Twin-Traction differential; the cone-type clutches have been replaced by disc-type clutches. Fig. 5 illustrates the exploded view of the latest type.

The disassembly and reassembly procedure with the exception of the clutches is the same for both types. When reassembling the disc type, the lugs of the plates are placed in the notches provided in the housing. Note the relationship of the discs to the plates; the two friction discs are placed between the plates.

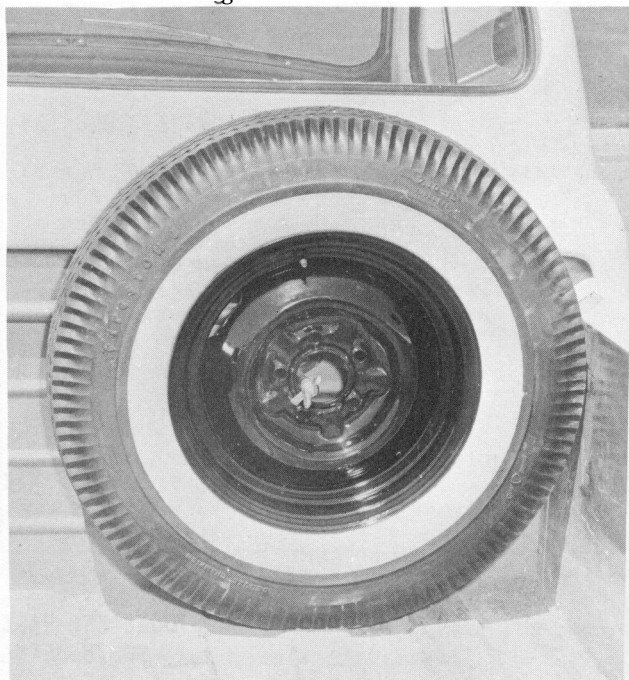
Fig. 7

Recently a new location for the spare tire was released as a factory installed option for trucks equipped with a pickup body. At the optional location, the tire is mounted at the front wall of the body (see Fig. 7). This can very readily be adapted to prior models for owners desiring this "in the box" location.
