## Borg Warner DG-200 front pump repair

**By Maxime Palandre Bedard –aka Max162**

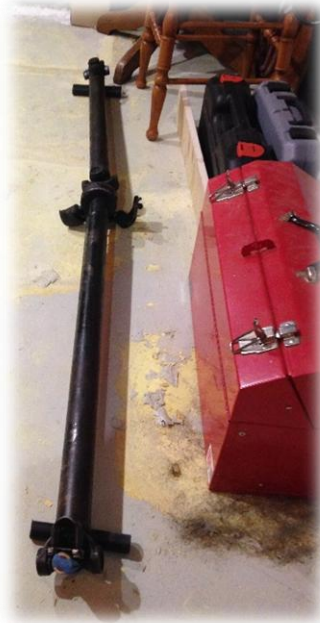
Lift the vehicle and safely secure the vehicle, so you can work under it. Start by removing the drive shaft and anything that can be in the way as documented by the procedure found in the maintenance manual. Accomplishing the initial removals is

required to assure you will have sufficient clearance when removing the transmission from the vehicle.

Tip: Once the drive shaft out, store it straight on the ground with the ends lifted a bit, just to keep it intact and straight. Make sure that you have either taped the universal joint caps to the universal so that they do not accidentally fall off the joint.

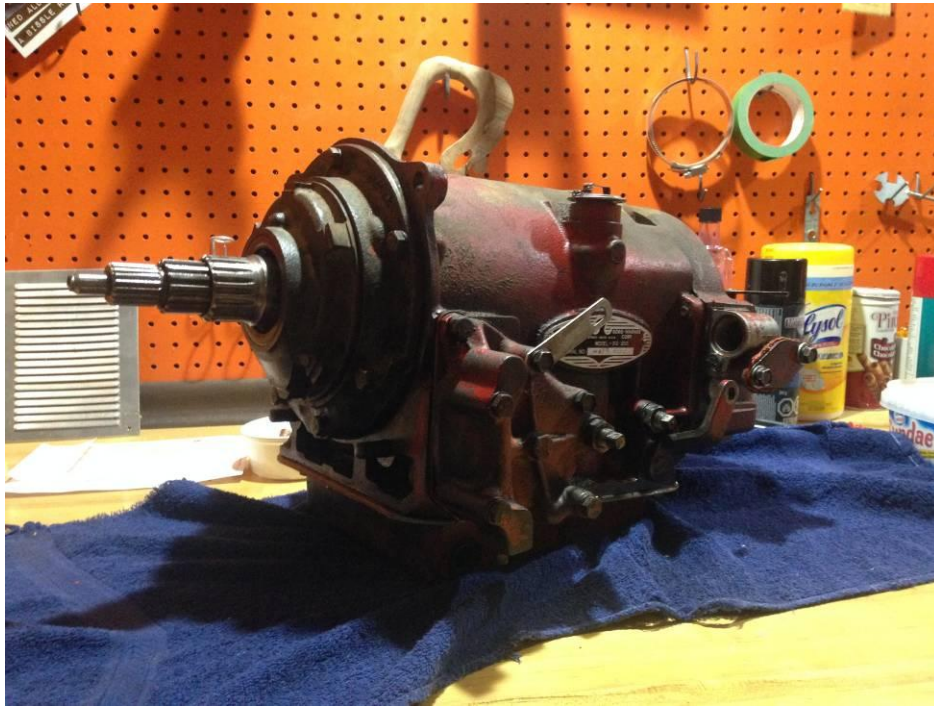
As seen on the picture above, the front pump assembly is located in the front of the transmission and is ready to be disassembled. At this stage the service manual will come handy as though not very complicated, there are procedures to respect in order to properly repair your transmission.

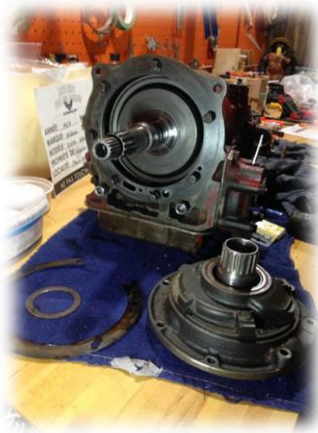
The first thing to do is to remove the front pump from the transmission case by simply removing the 7 cap screws. Don't forget to inspect the transmission case's mating surface for any possible wears and nicks. Once the front pump in your hand, disassemble the front pump by following the manual.

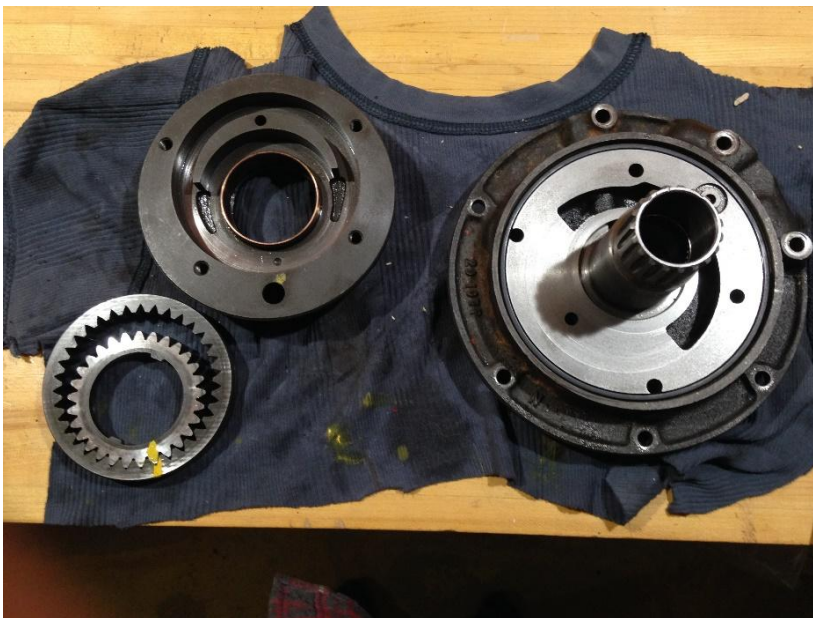
For the front pump gears, mark them for proper reassembly mating before removing them. With the front pump disassembled, it is time to inspect it. Look for nicks and wears on the collector ring and the front pump body.

Inspect the front pump gears for wears and replace them if necessary. Replace the two O-rings, the front pump seal and the collector ring to transmission case gasket.

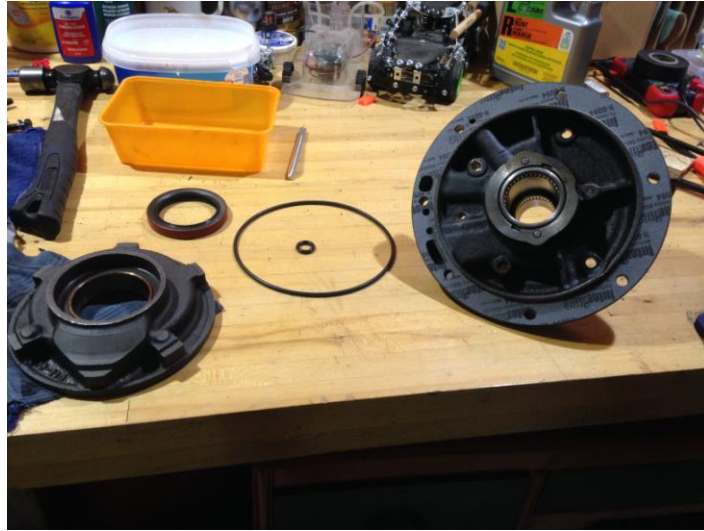
Inspect the front pump seal and replace it is necessary.

Front pump seal:

- Front pump seal Timken #470898: General Bearing Service Inc. (local shop)

Once the parts gathered, it's time to reassemble the front pump by following the steps in the service manual and reinstall it onto the transmission.
