Studebaker

# SERVICE BULLETIN

NO. 206

1948

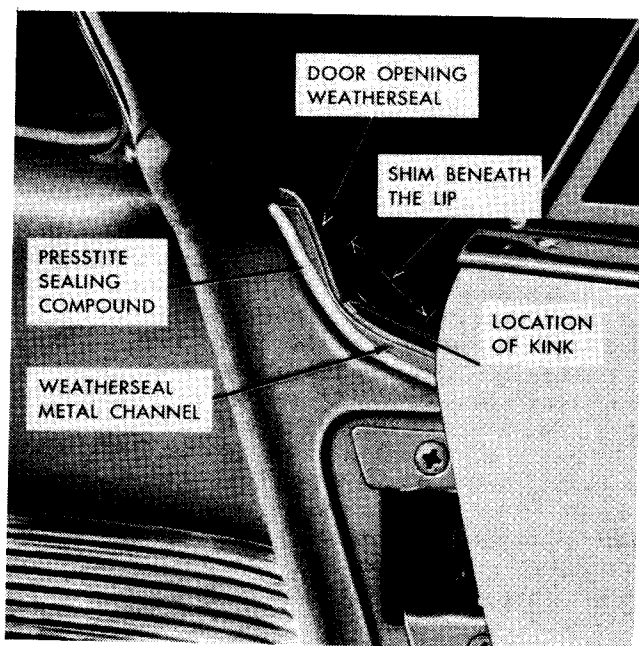
**DESCRIPTION:** This leak is located just above the upper door hinge where the weatherstrip and channel curve to follow the vertical contour of the body at the belt line. Water may leak either over the rubber weatherstrip as a result of a kink in the rubber caused by the curvature, or between the metal weatherstrip channel and the body, work into the car, and run down the windlace. See illustration below.

**HOW TO FIND:** Spray water over the shroud; inspect door opening weatherstrip and windlace.

**HOW TO CORRECT:** If weatherstrip is kinked at the belt line, place a piece of round, 5/16" soft rubber weatherstrip, Part No. 1587XD six inches long under the lip of the door opening weatherstrip. This will eliminate the kink

and provide a positive seal between the door and the weatherstrip throughout contour at the belt line. If the water enters between the weatherstrip channel and the body, apply Presstite sealer along both sides of the channel across the gap in the channel and for four inches above and below.

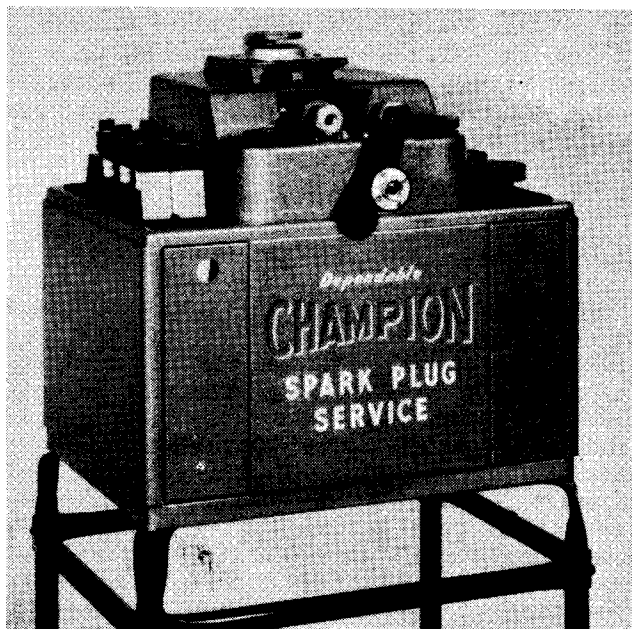
The Comparator is a complete testing, cleaning, and comparing unit housed in a strong, neat steel cabinet. There is storage space for gaskets and adapters and the work surfaces are rubber covered. A steel stand is available for floor or portable installation.

The Comparator test is so built into the machine that a customer's spark plugs can be individually compared with a new plug, the customer being able to compare visually on a dial the intensity of the two sparks. The results of this test alone are usually sufficient to sell new spark plugs to any customer whose old plugs show up poorly in the test.

Cleaning of spark plugs is accomplished in three seconds by the use of individual abrasive

and air blast valves which clean and dust in one operation. Dust tight, flexible adapters make it possible to clean any size spark plug. Among other features the Series 500 Comparator has a built-in water trap and a single air connection, either permanent or portable.
