# Avanti Repair

## Avanti Power Window Repair, A to Z

How to restore speed, precision and make everything work as good as new

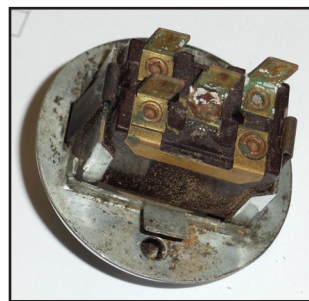
*The terminals on the back of this riser switch feature fifty years of tarnish and corrosion. Gently take steel wool to every visible electrical connection to reduce electrical resistance.*

be considered suspect. Moist air, salt water, and constantly changing temperatures cause tarnish and rust to form on any exposed metal. As boring as it sounds, separate all connections one at a time and clean each one with fine steel wool and electrical contact cleaner (available at a store like Radio Shack). Wear gloves to protect your fingers.

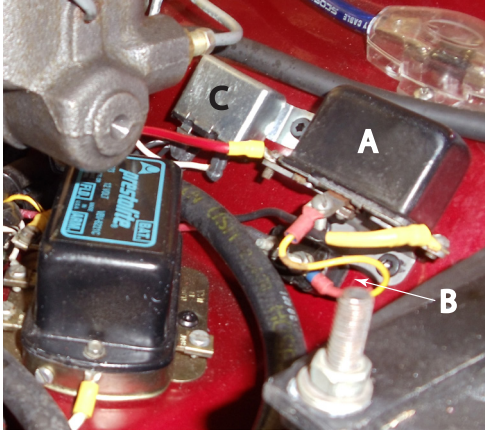
*Electrics on the car's inner left fender. Black box "A" with three visible terminals is the power window relay. Small black rectangle "B" below is the window circuit breaker. Silver relay at left "C" is for horns.*

Remembering that all electrical devices need to be grounded to work, I first checked to see if the relay was grounded and found that the white wire that went to its base was indeed slightly loose. Cleaning the connection and tightening this bolt solved the problem immediately. Now, when the key was turned the relay clicked "closed" immediately, full power was being delivered to my windows regularly and I had solved my first problem.

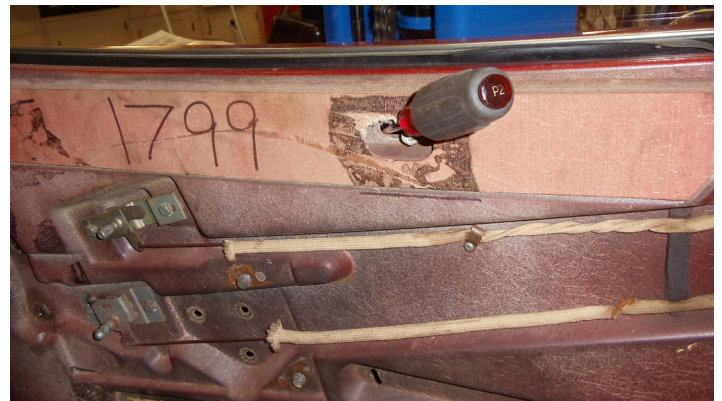
*The riser mechanism “as removed” from the passenger door. The position of the half-moon gear shows that the window would be all the way up in this position. All tension is off this spring; it can be removed without effort. That is not right; as even when fully down, the window spring should retain some of its tension. Rusty spring was sandblasted and greased before proceeding, to help it move more easily as it coils.*

down, the assist spring is wound its tightest. Unbolting the motor from the riser assembly with the spring twisted closed may cause it to come apart with some sudden force, which could hurt you and break something besides. (If your motor is inoperable, you may want to clamp the spring in its current position with a c-clamp or a large vice grips while you remove the motor. At any rate keep fingers clear of the large half-moon gear and the reach arm when unbolting the motor as they may move suddenly.)

After thoroughly cleaning all of the points where metal touches metal (I soaked the whole assembly, minus the motor of course, in the de greasing tank) I sandblasted the rusty spring (though using emery cloth would work well too, only take longer.) I re-greased the spring and all points of metal to metal contact with white grease. A little is all that is needed, smeared on the specific points of contact. Do not use wheel bearing grease or any other heavy grease. It is not meant for this type of duty, and will gum the works up.

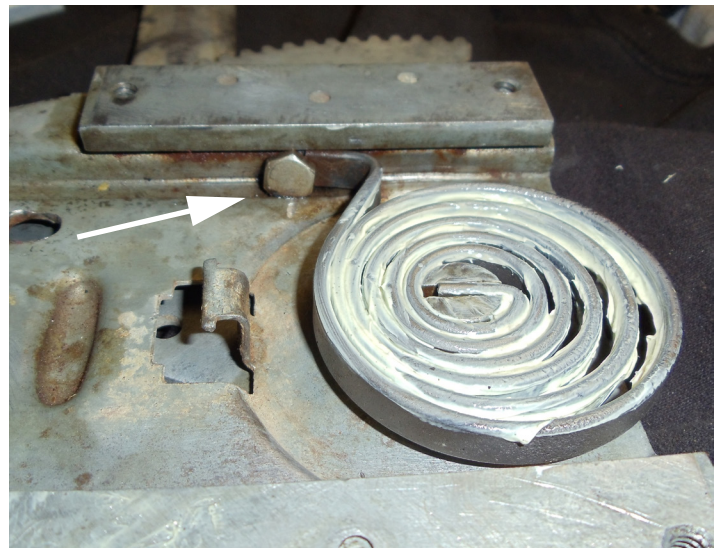
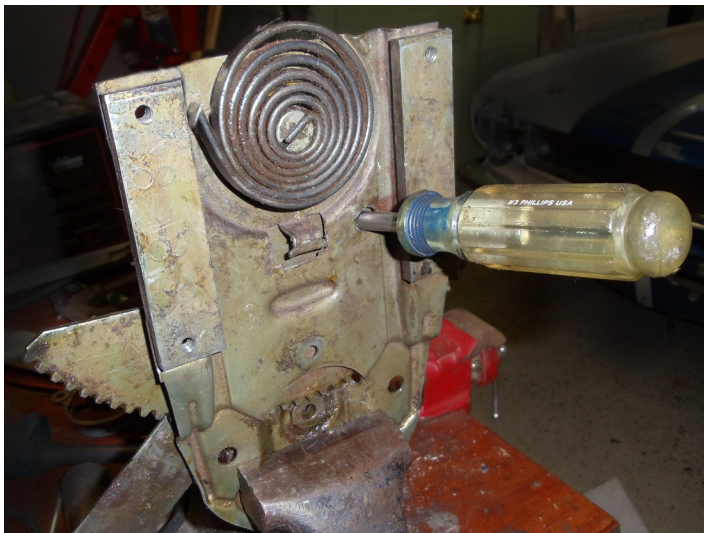
In the case of my passenger side window, I decided that if the spring could be wound a little tighter, it might solve both the issues of the window falling too fast and rising too slowly. Yes, these springs lose their tension over the years. Notable was the fact that when the mechanism was at “fully raised” position. The spring had almost no tension on it and could be removed easily without tools. This is not right; the spring should retain some tension, even when the window is all the way up.

If you watch the coiled spring carefully while the motor runs through its full up/down-travel, you will notice that it turns and compresses only about half a turn. The only way to adjust the spring is to install it pre loaded, so that when the window is fully open, the spring is still trying to push it up more.

Logically, if one could simply remove the spring from its mounting slot, and rotate it clockwise by 180 degrees, then reattach it while keeping the end mounting tab in its hole, one will have accomplished this feat. The problem with this is that it is nearly impossible to turn this spring even a fraction of an inch by hand, let alone another half turn!

So, here is the trick: Because a half turn was too much for this particular spring, I made a new mounting point for the spring's base by welding a sturdy bolt into a hole I drilled in the window winder frame. Spring in place and motor still removed of course, clamp the riser frame securely in the table vice between two pieces of wood (to avoid bending or otherwise marring it), push on the reach-arm, and very carefully but very firmly rotate the gear to line up the two alignment holes (one is in the frame, the other is in the half-moon gear). You will be pushing against the increasing spring pressure. Make sure you are wearing gloves, the mechanism is not greasy to ensure a good grip and get someone to help you if you are at all unsure of your steadiness. Then, have a helper quickly insert a long Phillips screwdriver blade through the two alignment holes provided for just this purpose, jamming the mechanism in place. Screwdriver still locked in place, remove the assembly from the table vice, and carefully reinstall the motor to the frame using two of the bolts with lock washers. Note that the third (center) bolt is not accessible with the half-moon gear in this position.

Once the motor is tightened to the frame with the two bolts, you can remove the screwdriver from the alignment holes, as the motor gear will hold the spring tension. Now, with great care, briefly apply power to the motor leads again, bumping the gear to near the end of its travel, and exposing the third and final bolt hole. Install the third bolt and nut with lock washer.

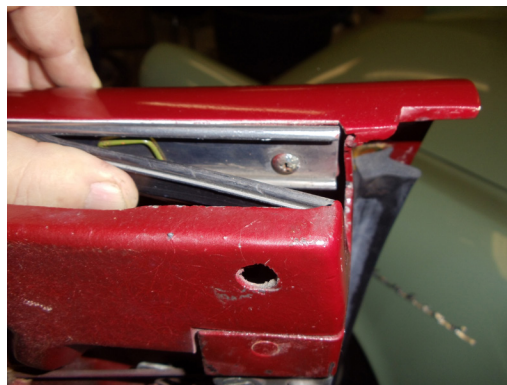
*Outer rub strip is captive in a stainless channel that must be reused, and is connected to the door with four spring clips and a single screw. Replace it now while the window is apart.*

With the glass out of the way, use a sharp knife to cut away the very rear edge of the old rubber, exposing the screw beneath it. Remove the screw using the access hole thoughtfully provided by South Bend. Being careful of the paint, insert a non-marring prying tool between the painted door and the stainless trim and pop the four spring clips out of their holes on the door. The strip is pinched at its far front end in between the painted door and the vent window; shift the vent window forward again to allow the strip to be pulled free.

With the stainless strip removed and on the workbench, score the old rubber down the center with a sharp knife, split it and carefully pull it out and discard. Steel wool the inside of the stainless strip, spray a small amount of WD40 or other lubricant into the channels, and slide the new rubber strip in place, leaving the screw hole

at the far back temporarily exposed. Snap the strip back into place, reinstall the screw, and slide the rubber strip back into its final position, covering the screw. You may need to trim the strip at either end to allow it to lay flat against the window glass.

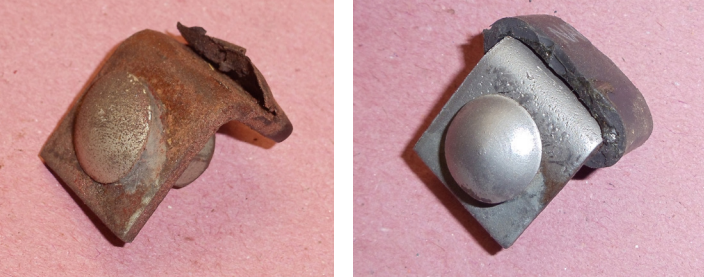
Top stop, sandblasted and fitted with new rubber from a heater hose

Nothing more than a small L-bracket bolted to the door frame, the easily ignored (and possibly missing on your car) top-stop keeps the glass from going up too far. When properly installed, the top arm of the window scissors bottoms against this adjustable stop. Close inspection showed that while it was originally covered with a thin cushion of rubber, the years of use had caused the rubber to peel away, leaving metal on metal contact at the top of the window travel.

Removing the small stop, I used a tiny length of heater hose slipped over the end to replace the original rubber cushioning, and secured it in place with a dab of windshield sealer adhesive. When reinstalled and adjusted, the window nestles softly against the stop rather than hitting it with the former “clunk”. Little touches like this are what make an old car feel new again. If your top stop is missing altogether, Jon Myer has a supply of them for sale.

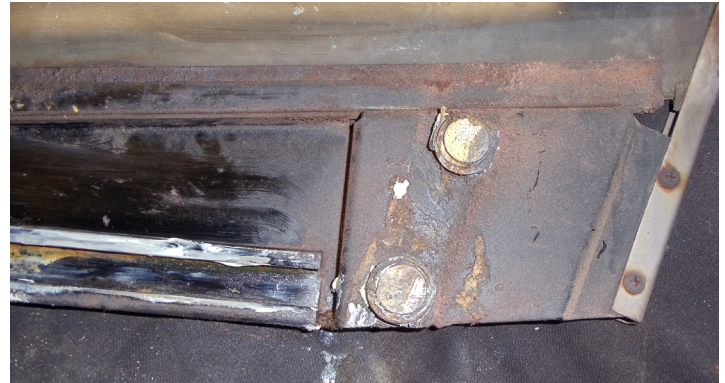
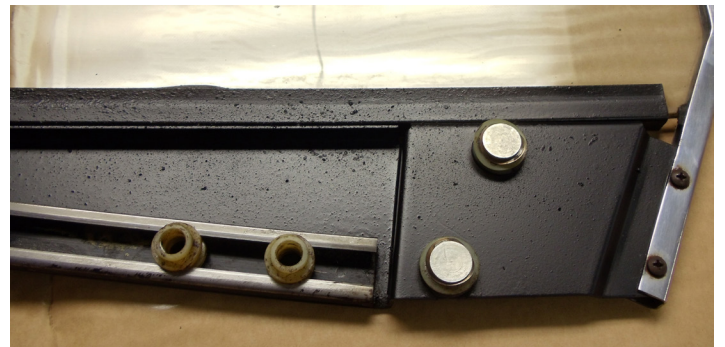
*Before and after, cleaned and painted*

from the frame, and repainted the bottom of the frame with Rustoleum. I used white lithium grease on the rollers and freshly cleaned rear glass track. Preferably with a helper, pull the loosened vent window assembly forward (tip it towards the front of the car) for clearance and reinsert the pane into both the front and rear channels at the same time.

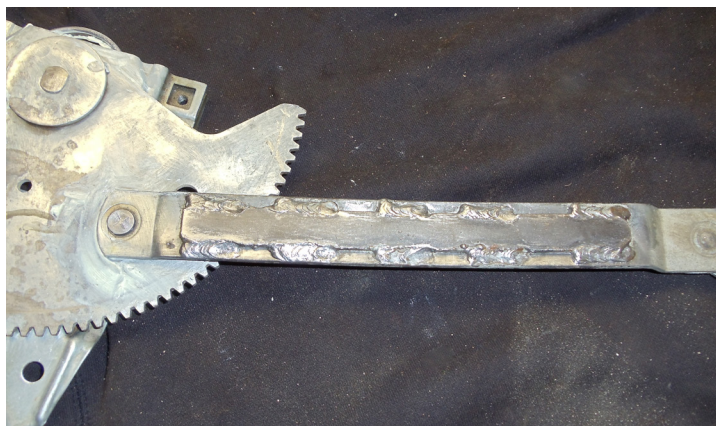
Just like the other door, when the window mechanism was fully raised, this uncompressed spring showed no tension. New exact replacement springs are not available, but a used rear quarter window spring from a GT Hawk in the 1962-1964 vintage is a suitable replacement. (These windows are typically barely used, and left raised most of the time, so their used springs are generally good-

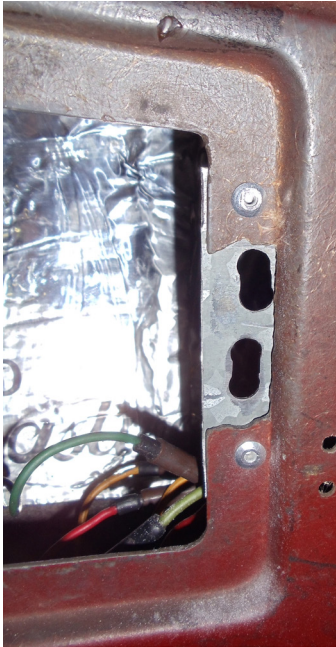
*The bottom stop on the driver side was missing because at some point it had been totally ripped out of the frame, breaking fibreglass as it departed. Period service bulletins indicate that this was not uncommon and a second lower stop was added on the other side when these repairs were made by the dealerships. I made my repair plate from a piece of scrap steel from a deceased wheelbarrow, and riveted it securely in place. New stop (not shown) was purchased from Myer's Studebaker.*
