Replacing Avanti's Steering Shaft Support Bearing

By: Bill Henderson

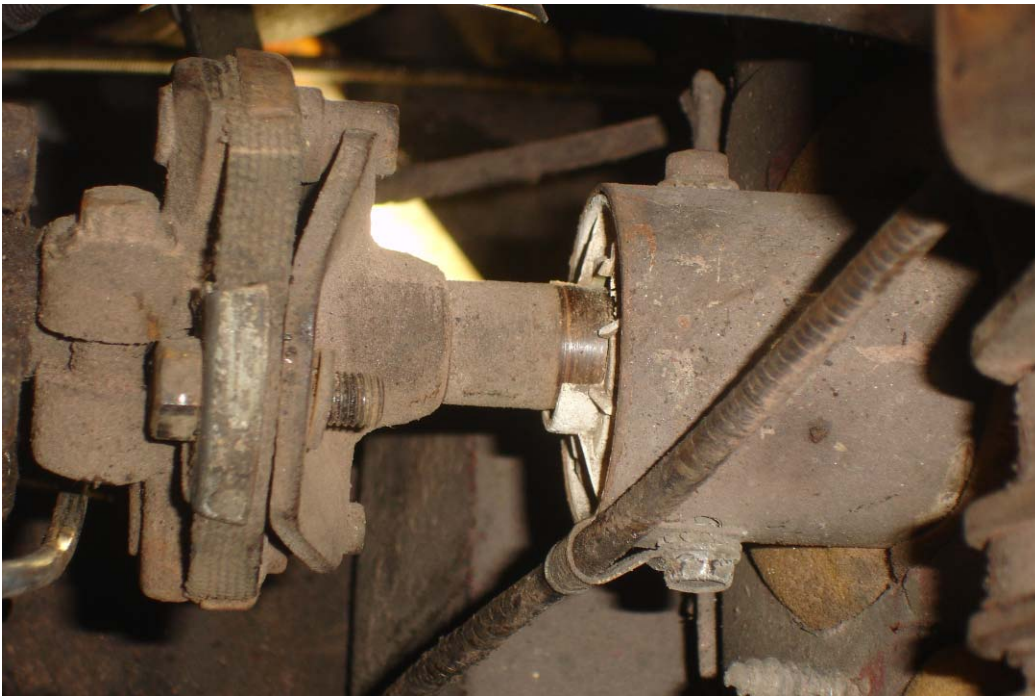
Photo 1 – Photo taken from above, after the removal of the Master Cylinder and Brake Booster

1. The steering shaft attaches to a rag joint at the steering box, in the engine compartment just in front of the firewall. The easiest way to get to this is by taking off the four bolts that connect the power brake booster to its firewall bracket; disconnecting the booster from the brake pedal by pulling the clevis pin; removing the brake hydraulic line from the master cylinder, and pulling the entire works – master cylinder and brake booster— out as an assembly. Total time for this pre-exercise was fifteen minutes, don't even think of trying to work around it unless you have hands the size of a three-year-old's.

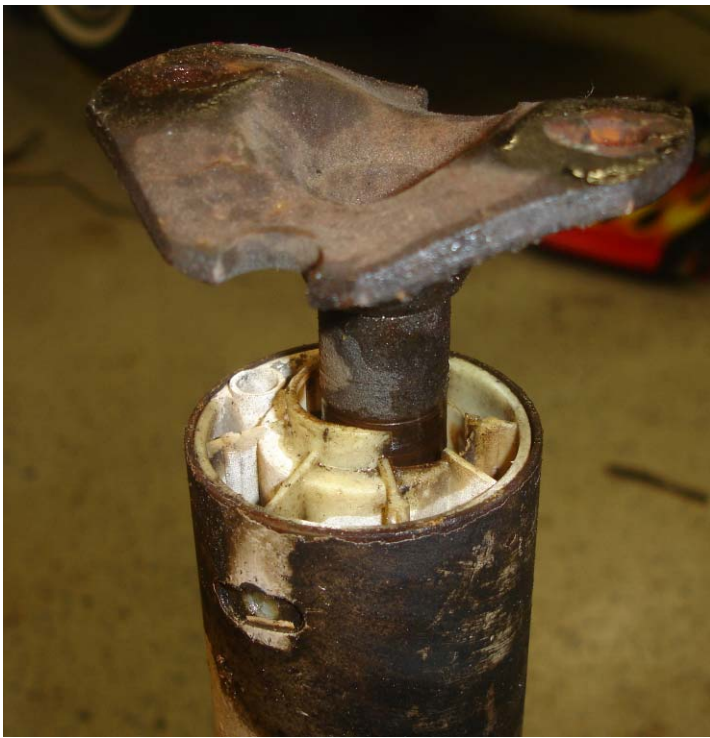
Photo 2- the worn bushing still inside the tube
 Photo 3- the entire steering column removed from the car,

Even though my Avanti didn't come equipped with tilt steering, wear in the steering column had caused a troubling sloppy looseness that allowed me to move the wheel up and down nearly a half inch while sitting in the driver seat. Examination showed that the large plastic bushing at the bottom of the steering column had become worn so the hole that the steering shaft passed through had become oval instead of round, allowing free play that if not unsafe was certainly not confidence inspiring.

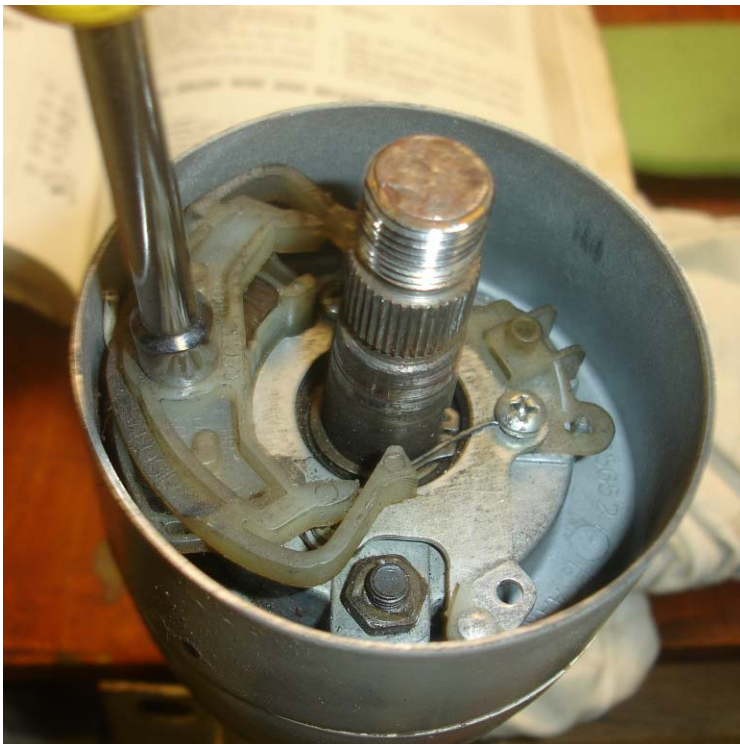
Photo 4- (accompanies step 7) Removing the turn signal lever and cam,
 Photo 5- (accompanies step 9) after putting a little slack in the wires, pushing the contact brush plate aside

7. Start by removing the long screw that goes through the pivot point of the turn signal cam. The turn signal lever will come right out. Next, remove the three screws that hold the turn signal cam ring to the upper bracket. Two Phillips head screws hold the upper bracket to the cone shaped trim housing below. When you remove them, the trim housing will drop free.

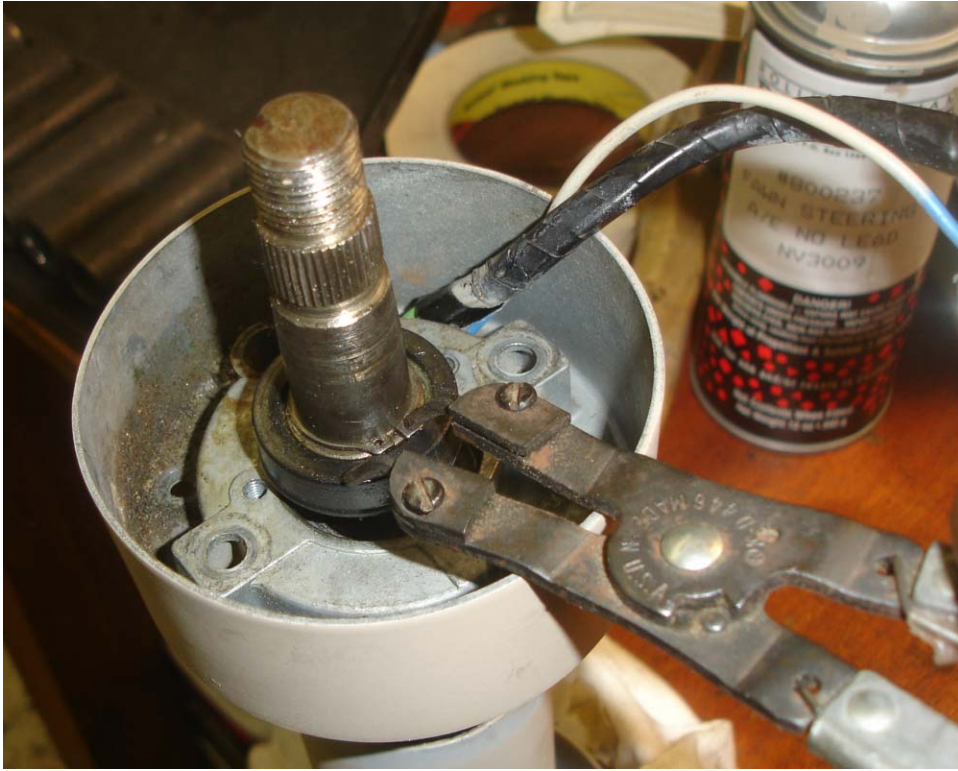
Photo 6,
(accompanies step
10) using snap
ring pliers to
remove the upper
lock ring

10. Use a pair of snap ring pliers (a great chance to buy a tool!) to remove the snap ring on top of the tiny bearing at the top of the steering column. This small bearing must come off as well. Do not beat on it; if it will not come off with simple pressure use a bearing puller. Mine came off with just a few taps to the center of the shaft.

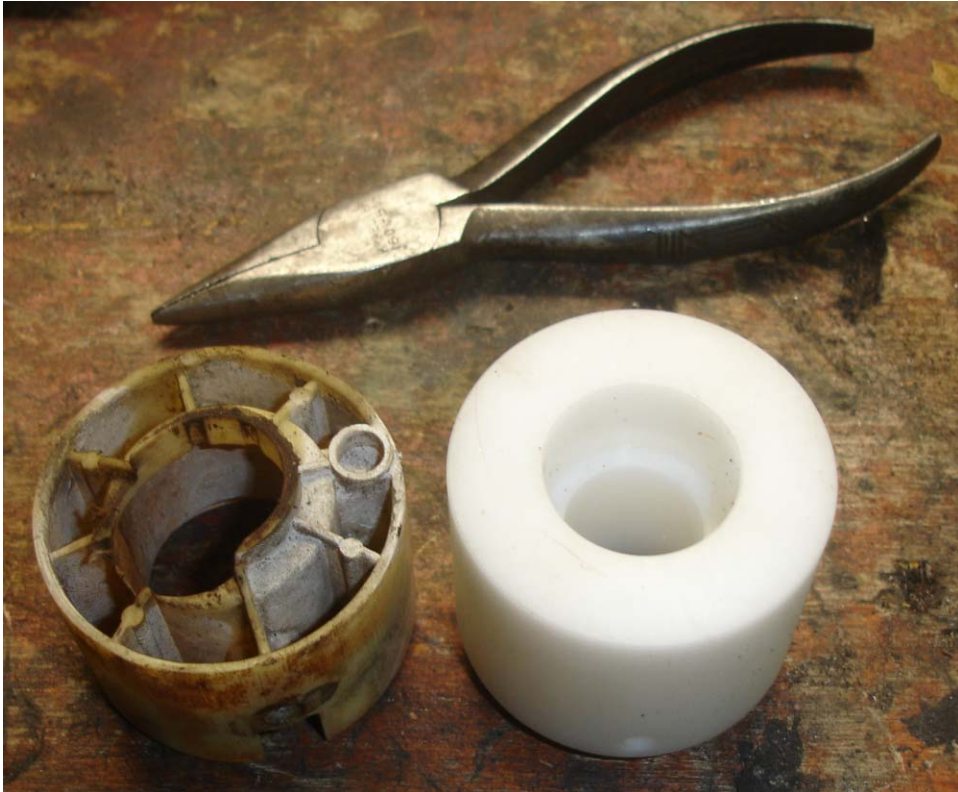
Photo 7 (below) –
(accompanies step
13) the worn
bearing next to the
new one from
Studebaker
International

12. Bearing lock rings removed, the shaft will slide down and out of the hub, and the entire shaft will slide out of the column jacket.
13. Here is the culprit—the old worn out bottom bushing next to its new replacement available from Studebaker International. The new part is nylon, and quite a bit more stout than the old one.

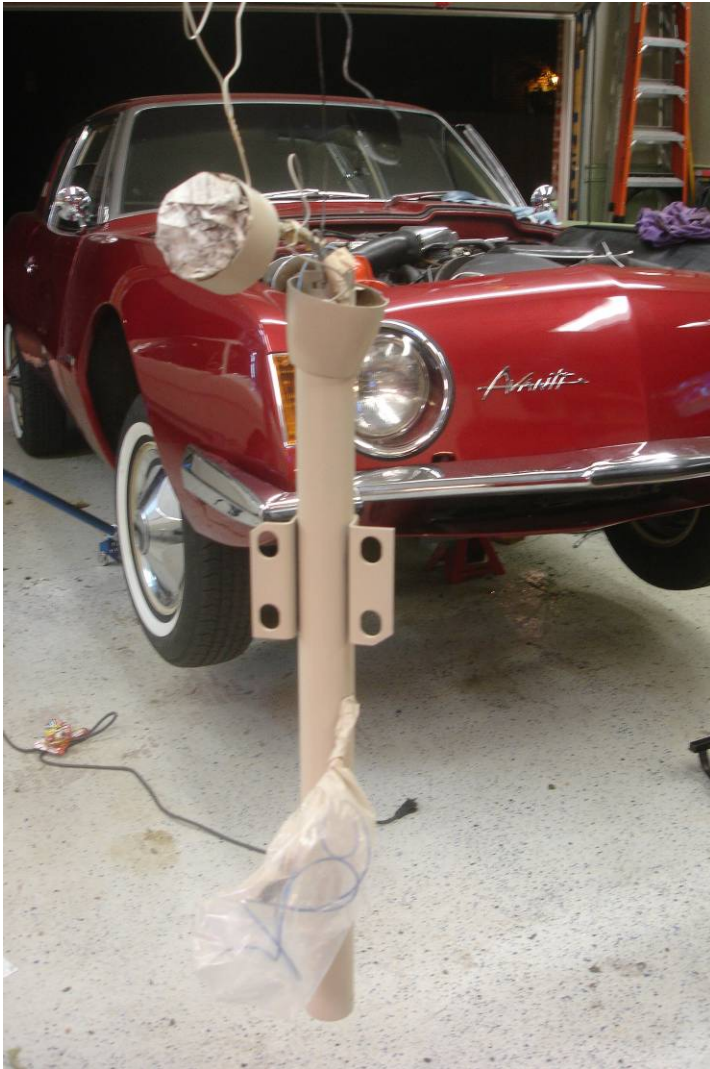
Photo 8- (accompanies step 14)
Painting the column while out of the car. I have a clothesline string across my garage and a supply of wire coat hangers that makes parts painting easy and fast.

14. Having everything apart was a great opportunity to clean and paint the column.
15. Reassembly is exactly the reverse of disassembly. Slip on the new lower bushing, first coating the inside with white grease, and screw it into place. Slide the hub onto the shaft (don't forget to put the cone shaped trim piece on first!) and replace the lower snap ring. Gently tap the tiny bearing into place (after temporarily removing its rubber slipcover and repacking the bearing with fresh white grease), then replace the upper snap ring. Replace the turn signal lever stalk and screw the turn signal cam assembly into place.

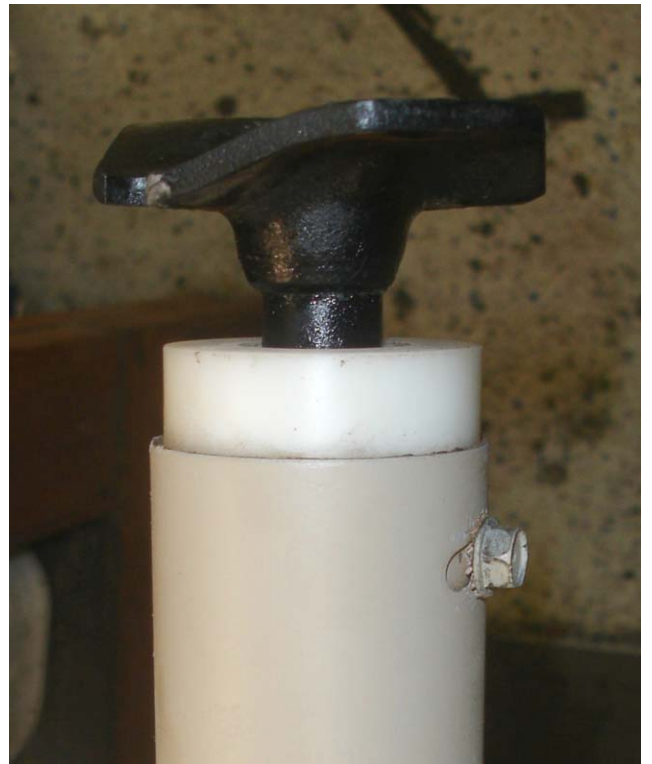
Photo 9- The new bushing installed inside the column

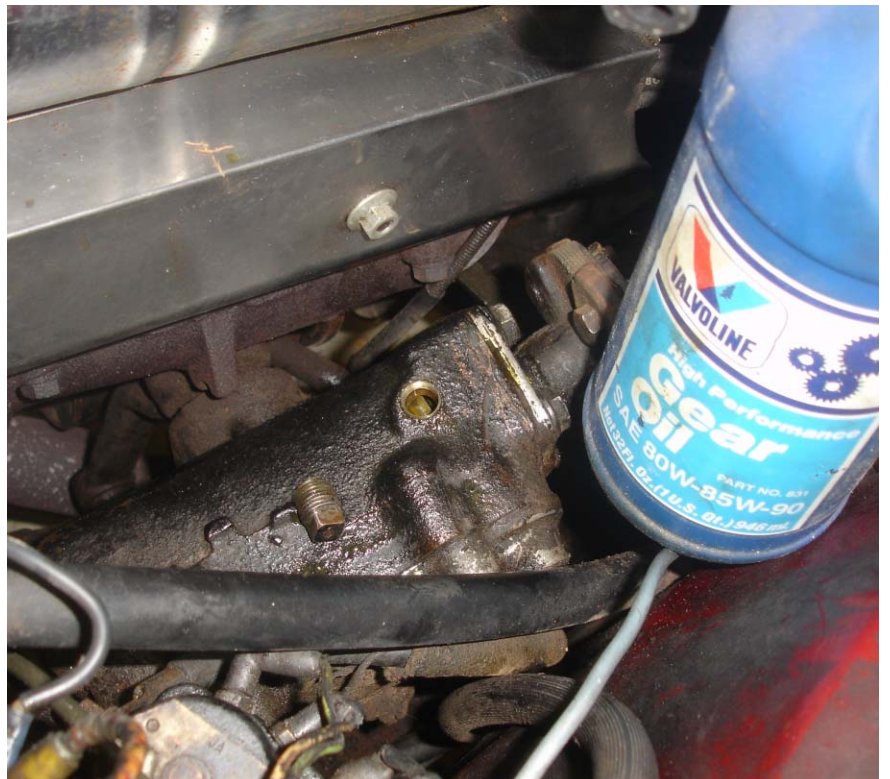
Photo 10- (accompanies step 16) Use this opportunity to check the lubricant level inside the steering box and add as needed.

16. Before putting the column back in the car, use this opportunity to check the level of the gear oil in the steering box. The box has a side plug that should be removed, then remove the top fill plug (an 11mm socket works well). Add 80-90 weight gear oil until oil drips out of the open side plug.

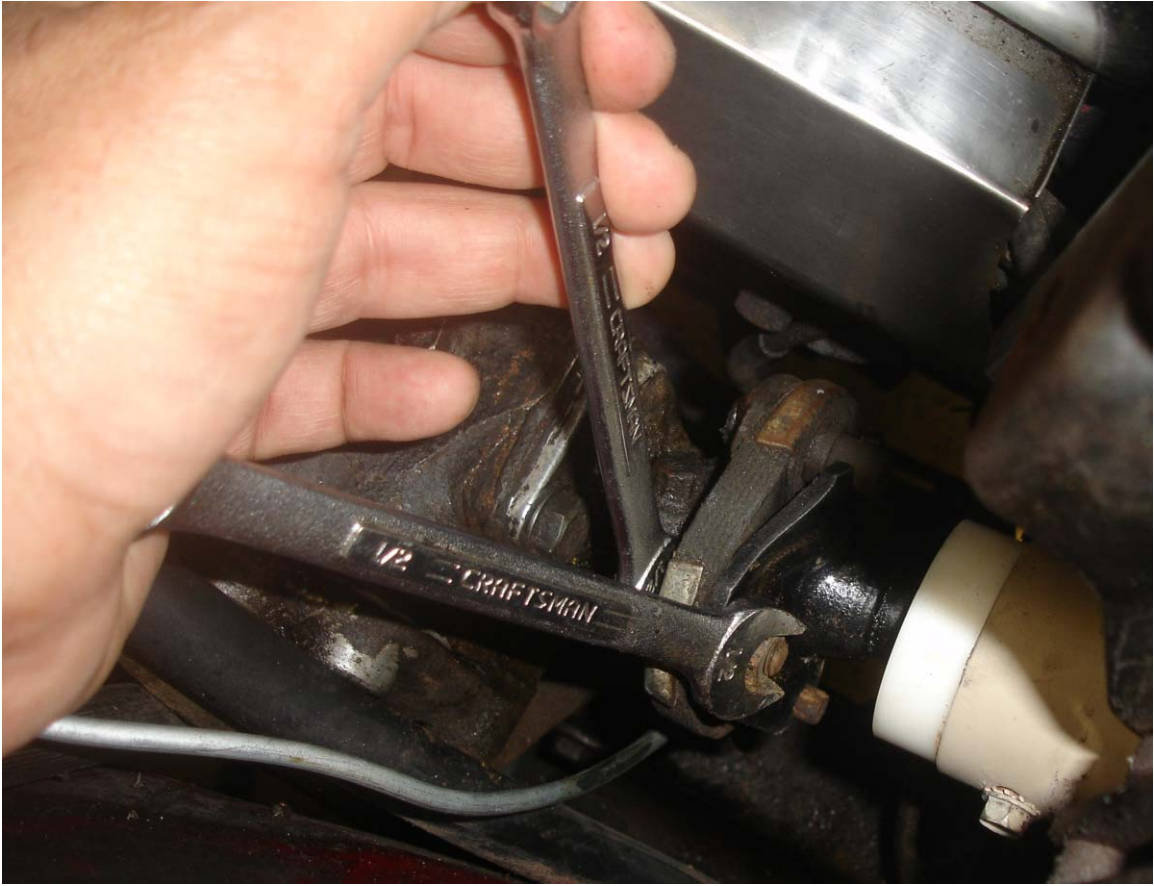
Photo 11- Using two box wrenches to reinstall the steering shaft to the steering box.

17. Slide the column into place, replacing the firewall rubber gasket if yours is torn or worn out (mine certainly was.) Bolt the column to the steering box rag joint, and bolt the column to the under dash support inside the car. Replace the steering wheel (ensuring that the wheels are straight ahead) and torque the nut to spec.
18. The brake booster and master cylinder goes back in as a unit, and since the system has been opened to the atmosphere, the brake lines will need to be bled to ensure there is no trapped air in the system.
