Studebaker SERVICE BULLETIN

NO. 236

1950

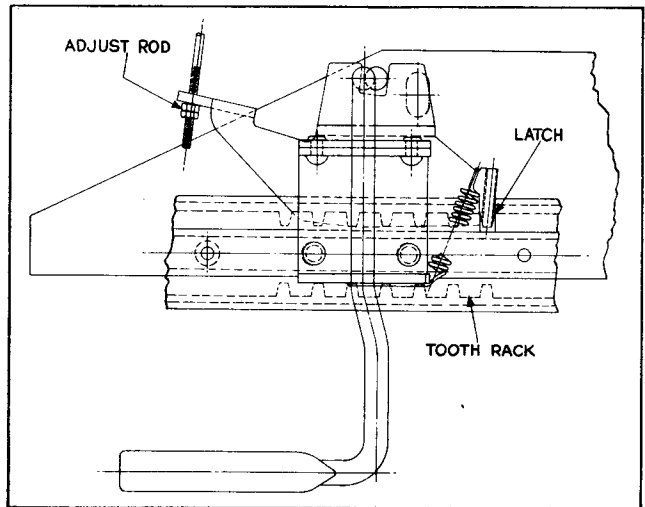
FIG. 8

The two latches which lock the seat assembly in position must engage fully, to prevent possible rattles. An operating rod adjusted too loosely will cause a rattle between the rod and the seat frame, while a rod adjusted too tightly will prevent one latch from engaging fully, causing a rattle between the latch and tooth track. The adjustment is made at the point indicated in the accompanying illustration (Fig.8).
