Studebaker

SERVICE BULLETIN

N O . 2 5 3

1 9 5 1

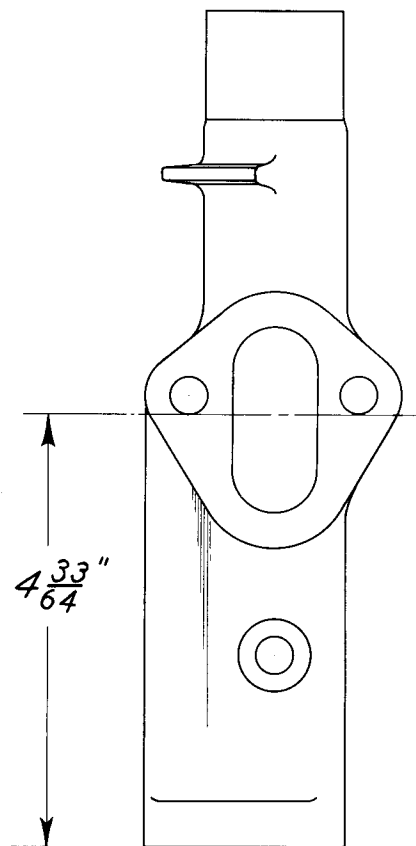
FIG. 2

3. **FUEL PUMP STROKE** After any air leaks in the fuel system have been eliminated, and the gasoline tank-to-fuel pump pipe is properly positioned, if the stalling condition continues, it is possible that the fuel pump stroke may be inadequate due to the mounting holes on the support being too high. The bottom of these holes should be not more than $4\frac{33}{64}$ " from the base of the fuel pump support casting (see Fig. 2). If the bottom of the mounting holes is higher than $4\frac{33}{64}$ ", replace with a new fuel pump mounting support, Part No. 529122, known to be correct as to this dimension. NOTE.--With the fuel pump support removed, be sure to check the fuel pump push rod for being bent or for evidence of scoring. If the rod is bent, replace the rod, Part No. 529123. If the rod is

scored, polish affected areas until the rod slides freely in the guide bore.
