Studebaker

SERVICE BULLETIN

NO. 266

1952 STARLINER MODELS BODY SERVICING ADJUSTMENT PROCEDURES

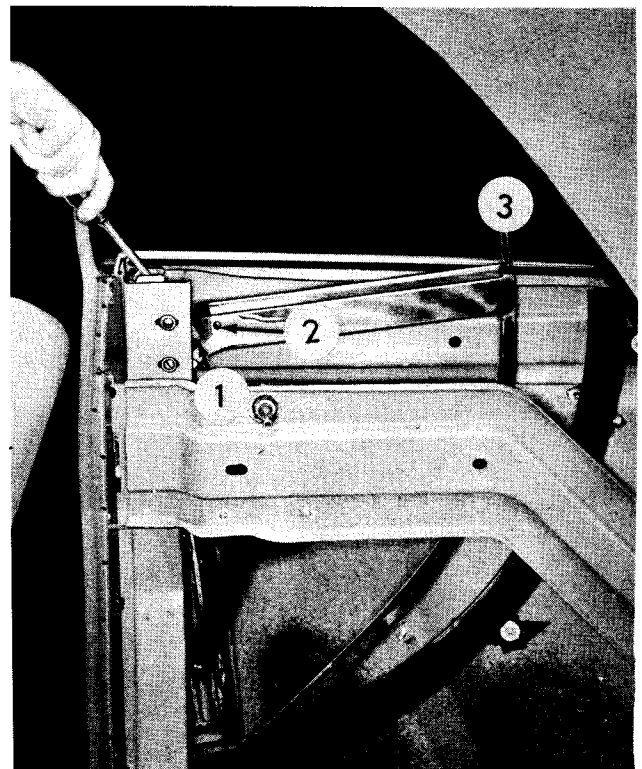
FIG. 7

The position of the window within the opening is controlled by the retaining screws (1, Fig. 7). The hinge and bracket assembly has vertical elongated slots to permit raising or lowering the window assembly. Also, horizontal slots in the mounting bracket permit moving the assembly forward or rearward (see inset Fig. 7).

1. RETAINING SCREWS 2. STOP SCREW

To adjust the window travel, loosen the stop screw (2, Fig. 7), roll the window into position so that the front edge of the window is parallel to the rear edge of the door window. Then, move the stop bracket until it contacts the window frame and tighten the stop screw securely.

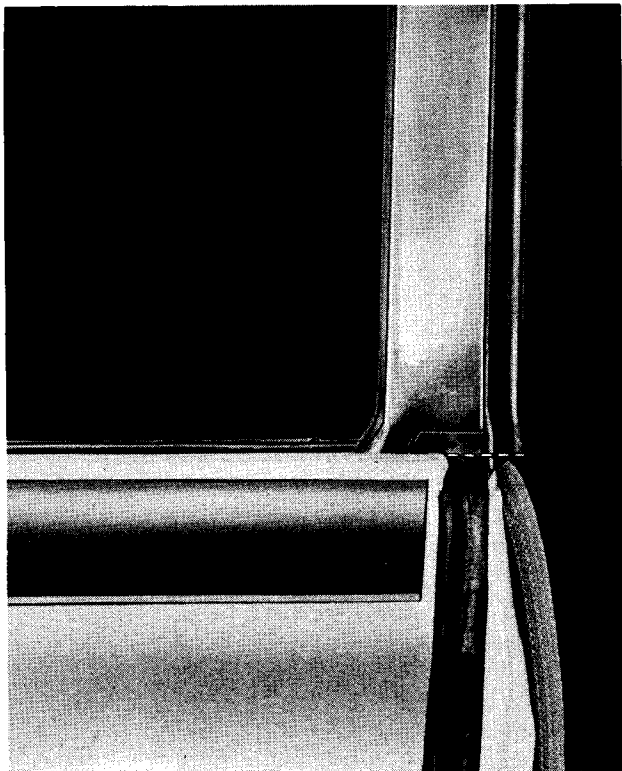
FIG. 8

1. WEATHERSEAL-TO-FRAME SCREW 2. WEATHERSEAL-TO-FRAME SCREW 3. WEATHERSEAL RIVET

If the weatherseal is torn or will not hold in the retaining grooves of the window frame, it should be replaced. To remove the rear quarter window weatherseal, the trim panel must be removed. Roll the window down to its full open position. Then, remove the weatherseal-to-frame screws (1 and 2, Fig. 8). Remove the weatherseal rivet (3) and pull the weatherseal out of the retaining grooves. To install the weatherseal, place the lower end of the seal in position in the frame and insert the weatherseal in the grooves of the frame. Install the weatherseal-to-frame screws (1 and 2, Fig. 8). Using an awl, make a hole in the upper end of the weatherseal to correspond with the hole in the frame. Then install the retaining rivet. Trim the upper end of the weatherseal so that it is flush with the top of the frame. Trim the lower end as indicated by the dotted line in Figure 9. The lower end of the seal should bear against the top of the door but must not be pulled inward as the door is closed. If the end of the weatherseal is pulled inward, an opening will result which will permit water to enter.

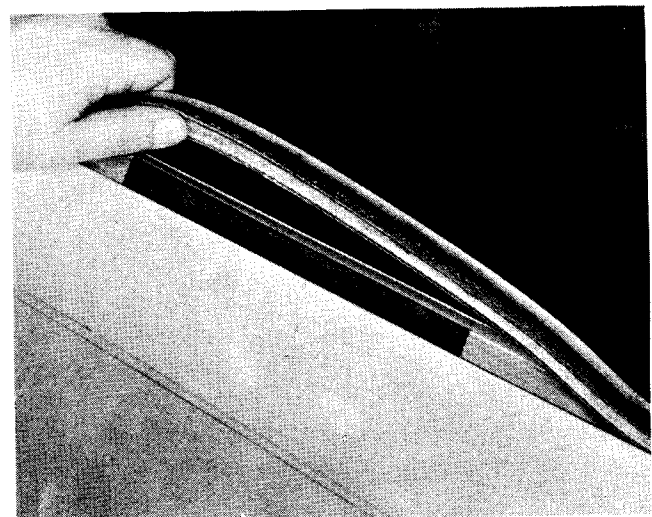
FIG. 11

To check the trunk lid for proper seal on the weatherstrip, insert a card, the approximate thickness of a business calling card, between the edge of the trunk lid and the weatherstrip (see Fig. 11) and move the card around the perimeter of the lid. The point at which there is little or no resistance indicates improper sealing. At this point pull the weatherstrip out of the channel and place a piece or pieces of rubber tape as required into the channel (see Fig. 12) to shim out the weatherstrip. Then cement the weatherstrip back in place in the channel.

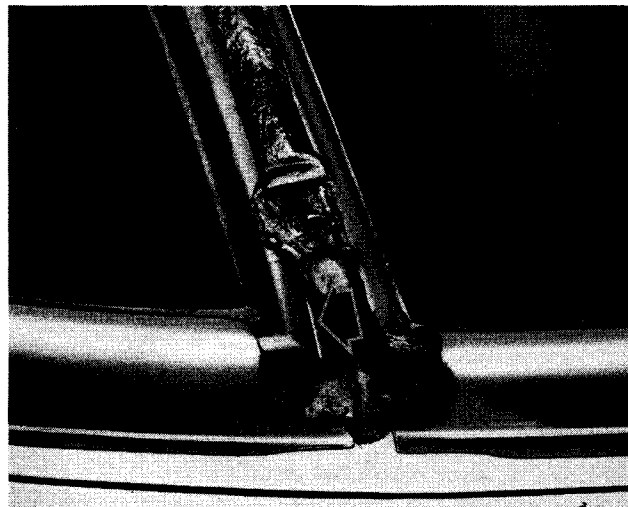
FIG. 17

Rear window leaks can occur between the glass and weatherstrip, the weatherstrip and body flange, and through the division bar screw holes. Leaks at the rear window will in most cases result in water in the luggage compartment with just a few instances when it will be seen on the rear seat back shelf.

If the water is not entering through the division bar screw holes, remove the outer division bar moulding and all rear window mouldings. Spray water first across the bottom of the center section, then across the bottom of the side section, up each division bar, and then across the top of the window. The procedure must be done slowly, taking a small section at a time and making a check at each section. If the leak is between the weatherstrip and the glass or between the weatherstrip and flange, lift the weatherstrip and apply the sealer under the weatherstrip. There is a tendency for the weatherstrip to pull away from the body flange at lower inside corner of the side section (see Fig. 17); therefore, carefully check this point and make sure that the sealer covers the opening.

of water are found on the moulding, spray the water at the top of the outer moulding only to determine if the water is coming through at the division bar screw holes. If leak is at one of the screw holes, remove the outer moulding and apply sealer to build up the area around the hole so that when the outer moulding is installed it will push the sealer in place to seal the opening.
