Studebaker

SERVICE BULLETIN

NO. 215

1949

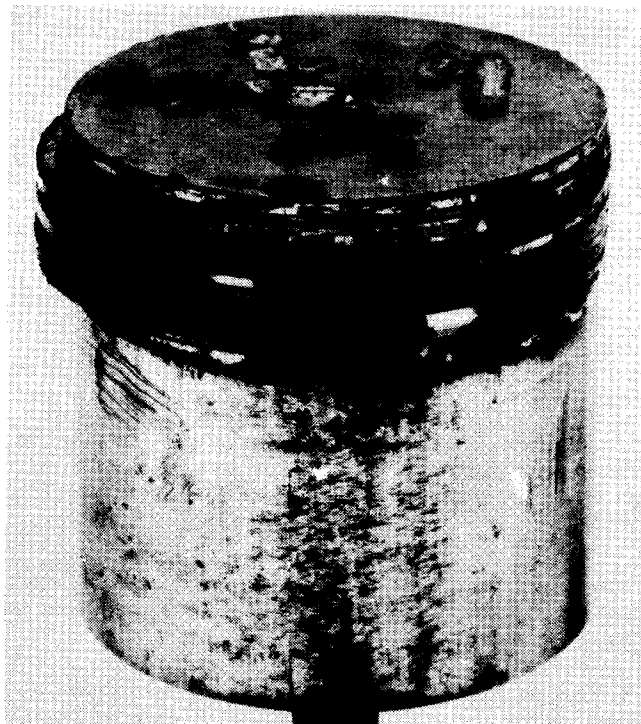
Stripped engine assemblies and individual metal parts shipped to dealers parts stocks are coated with a rust preventive compound to protect the surfaces from corrosion until they are to be installed.

This compound is not soluble in engine oils and therefore must be removed from all surfaces of stripped engines where it is applied, such as cylinder bore walls, piston heads, cylinder block top and sides, tops of valves, etc. The pistons, valves, and so forth should not be moved or the engine rotated at all until after the compound is removed. The accompanying illustration shows the gumming that results from failure to remove rust preventive compound before running the engine. Individual parts

coated with this material are easily cleaned before installation in an assembly by careful cleaning with kerosene or a similar parts cleaning solvent and blowing dry with compressed air. Be sure any oil channels or other interior passages are fully cleaned and swabbed.

In removing the rust preventive compound from a new stripped engine it is extremely important that none of the loosened compound be allowed to fall down into such places as the tops of piston rings, into valve ports, etc.

The safest procedure to follow in removing the compound from stripped engine assemblies is to lay the engine on its side so that none of the compound will be carried down past the piston rings during the application of solvent.
